# **Accessibility risk assessment of Ventnor High Street**

for  
Ventnor Town Council

May 2018

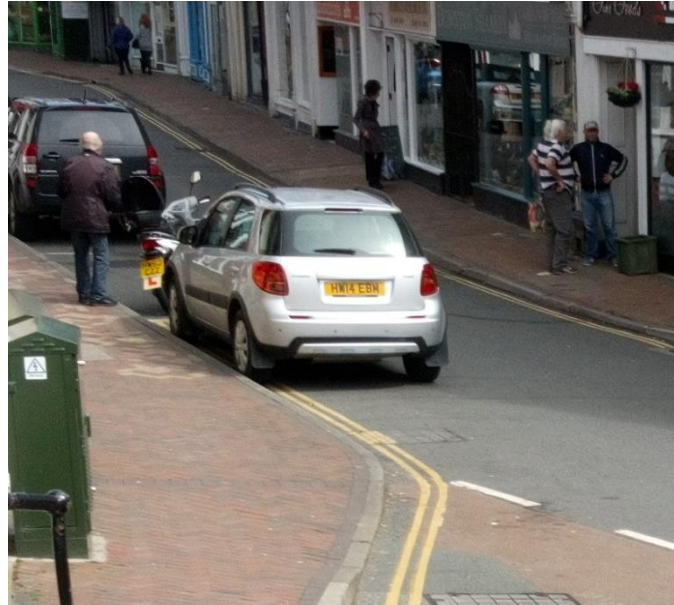
NB there are no blue badge parking facilities in this part of the High Street and all on-street spaces in this area were occupied at the time.

However, the car was parked in this location for over 2 hours and was causing problems for larger vehicles negotiating the corner (including buses).

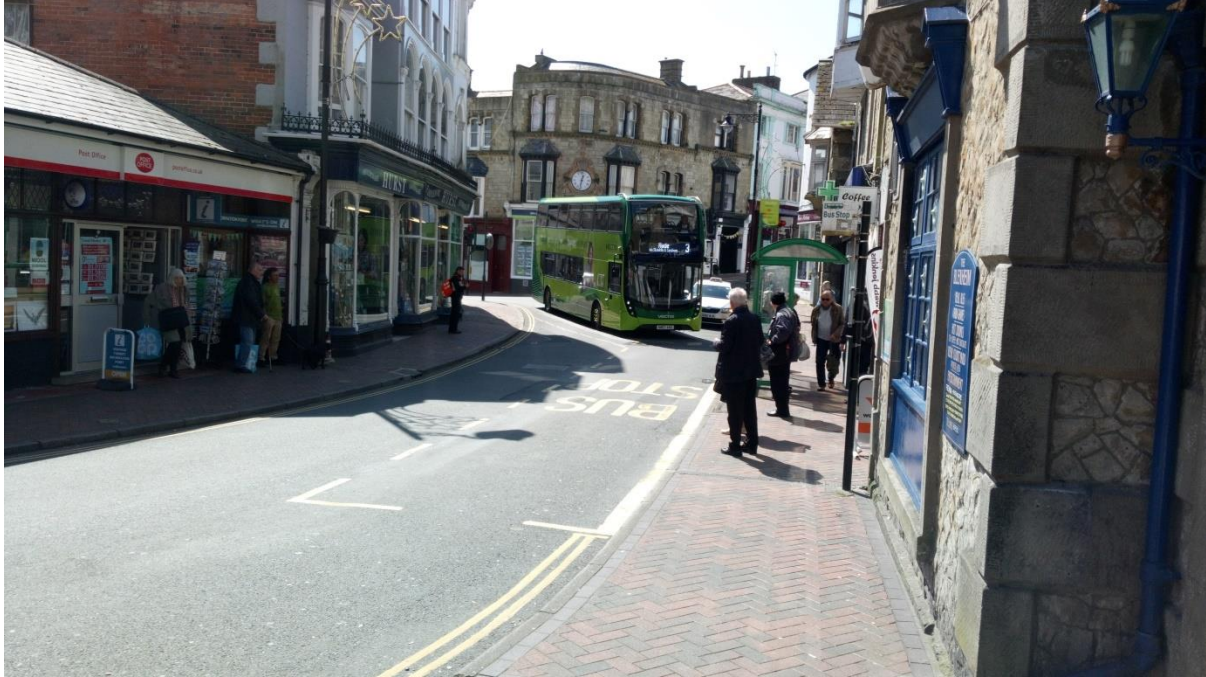
**Figure 2-F: Bus approaching stop outside Boots**

This means that buses cannot pull up parallel with the kerb at the front of the stop. The importance of pulling level with the kerb is explained in Paragraph 2.2.6 , including its relevance to accessibility.

Our site visits observed many buses arriving and departing from this stop: only the smaller vehicles used on the No. 31 and the 6 were able to pull in properly, whereas the larger vehicles used on the No. 3 could not. There were a number of occasions when two buses were using the stop simultaneously, although the stop is only long enough to accommodate one maximum length (12m) bus.

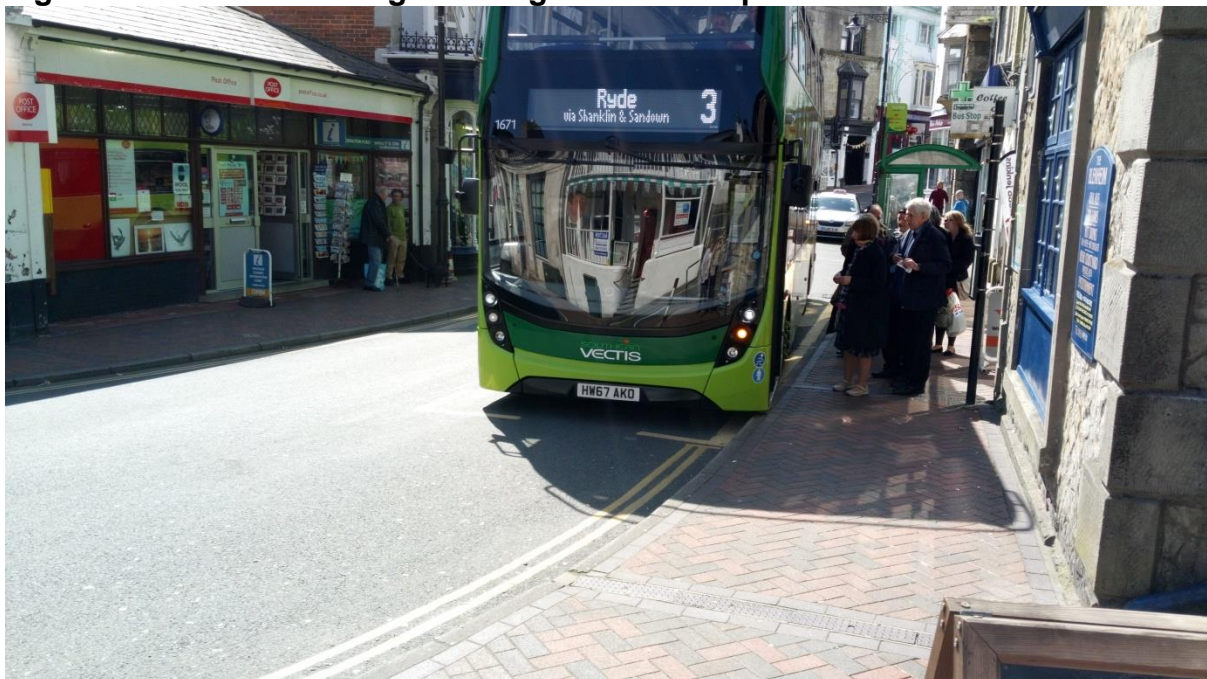
**Figure 2-G: Bus unloading / loading at Boots stop**

Using the bus's ramp, there needs to be adequate footway width for a person using either a self-propelled manual wheelchair or an electric wheelchair to board or alight from the bus.

However, for those using either a manual wheelchair (being pushed from behind) or a Class 2 mobility scooter (which has a longer wheel-base and larger turning circle) the current footway width may be insufficient and needs to be investigated further.

Accessibility for passengers boarding or alighting from the bus can also be compromised by congestion caused by the sheer volume of people on the footway (as illustrated in Figure 2-G and in Figure 2-U).

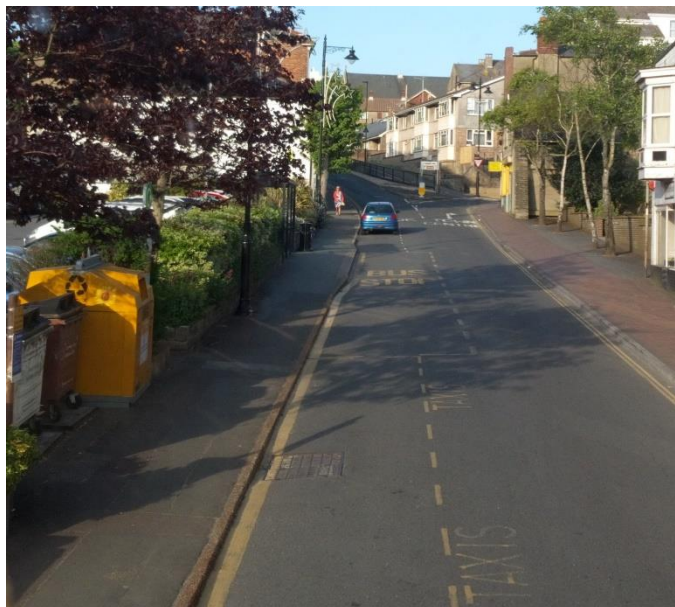
**Figure 2-H: Bus stop at Central Car Park**

The stop has a raised kerb to aid boarding for persons with mobility difficulties. The approach to the stop is straight, meaning that (in theory) buses should be able to pull up parallel to this kerb with a minimum gap. This manoeuvre is assisted by the raised kerb protruding slightly into the road to form a 'half-boarder' (see Figure 2-H).

However, there is a taxi rank immediately before the bus stop and if a taxi were to be parked on this rank then it could prevent the bus from coming in parallel to the kerb. We did not observe this taxi rank being used during the day-time, therefore this may only be a problem in the evening and is a relatively minor issue. This risk is also further reduced by the presence of the half-boarder.

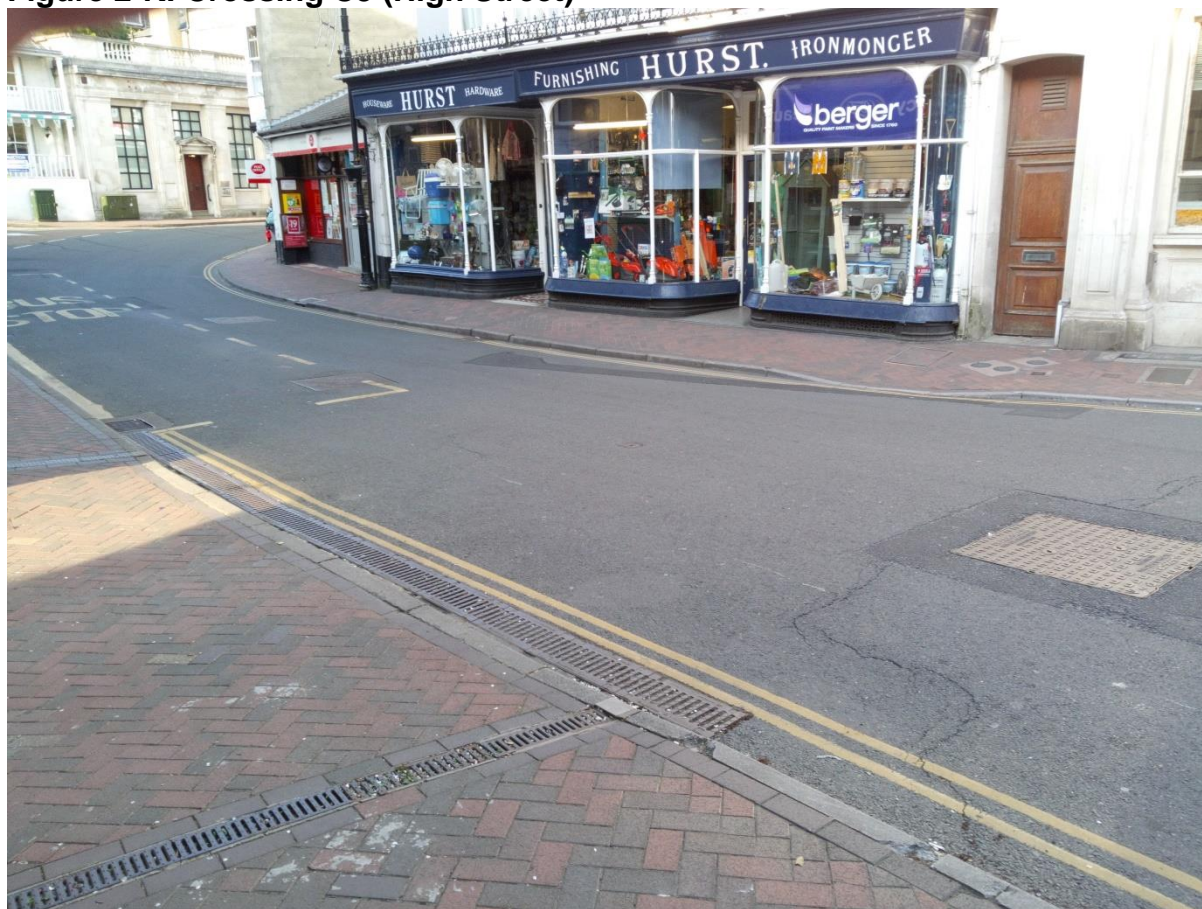
**Figure 2-K: Crossing C3 (High Street)**

The dropped kerb on the West side of Crossing C3 is also a 'vehicle crossover' or 'verge crossing' for vehicles entering and leaving via the archway between Boots and Hose Rhodes Dickson. Vehicles using this crossover would be in conflict with pedestrians crossing the road.

The poor condition of the dropped kerb (very uneven, typically 15-30mm upstand, but up to 46mm deep in places) may cause a problem for wheelchair users.

This, added to the presence of the grating over the drainage channel may also be a trip hazard to pedestrians attempting to cross the road.

The dropped kerb upstand on the East side of this crossing is 26-30mm (25mm max recommended).

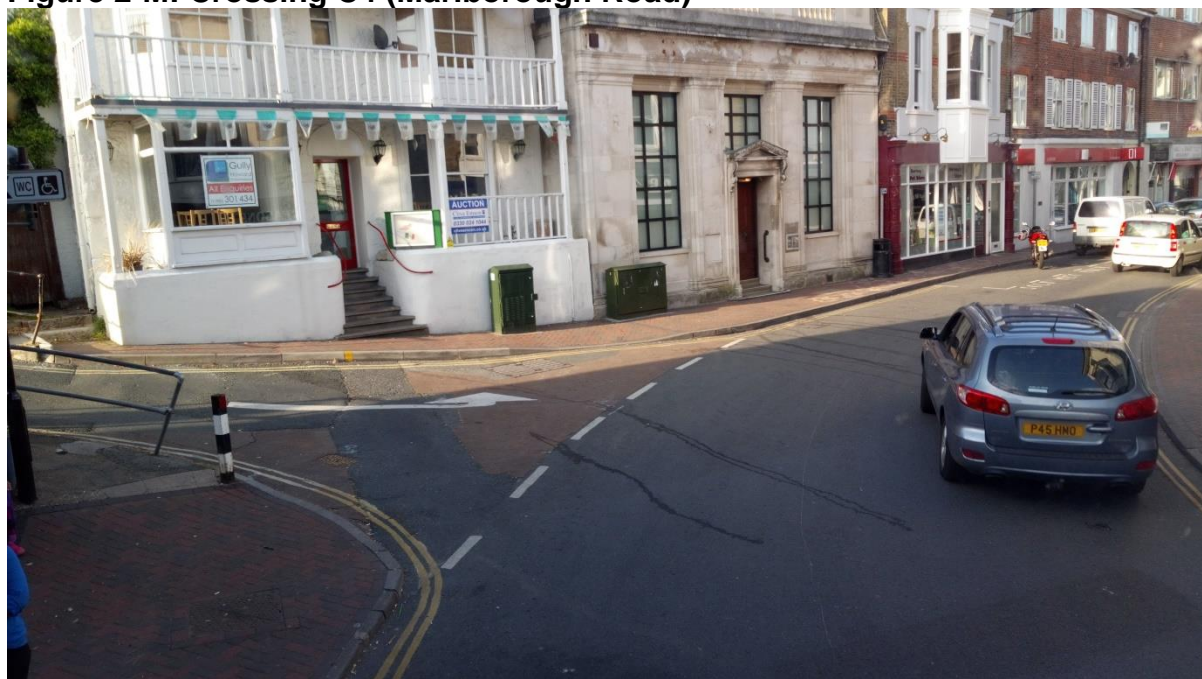
**Figure 2-M: Crossing C4 (Marlborough Road)**

There is no tactile paving on either side of the crossing to warn VI pedestrians that they are walking across a side road, or to align them with the opposite footway.

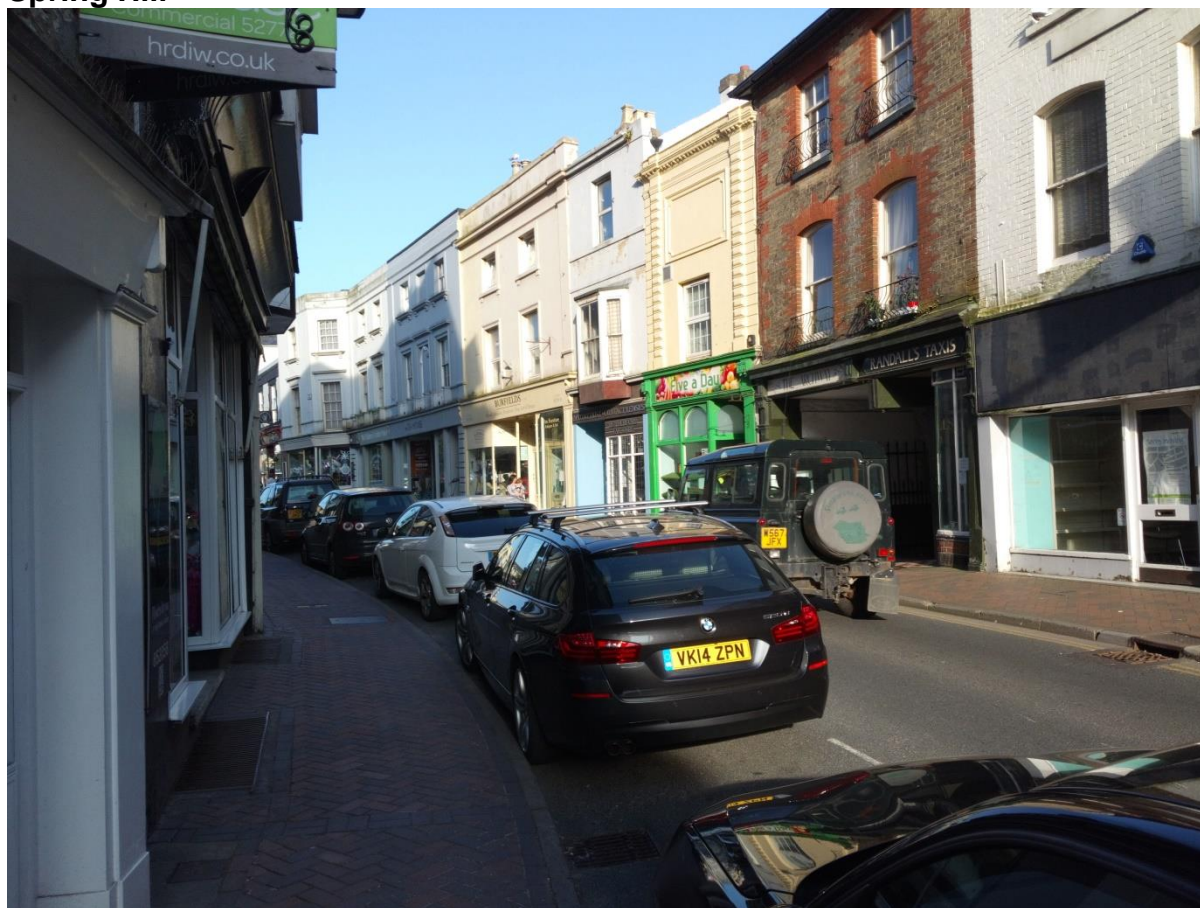
**Figure 2-N: No crossing points on High Street between Marlborough Road and Spring Hill**

In addition to this, short-stay parking is continuous along the north side of the High Street between Marlborough Road and Spring Hill (as shown in Figure 2-N). This parking appears to be in constant use throughout the day.

Thus safe crossing opportunities are limited, even for those pedestrians who can ascend / descend kerbs.

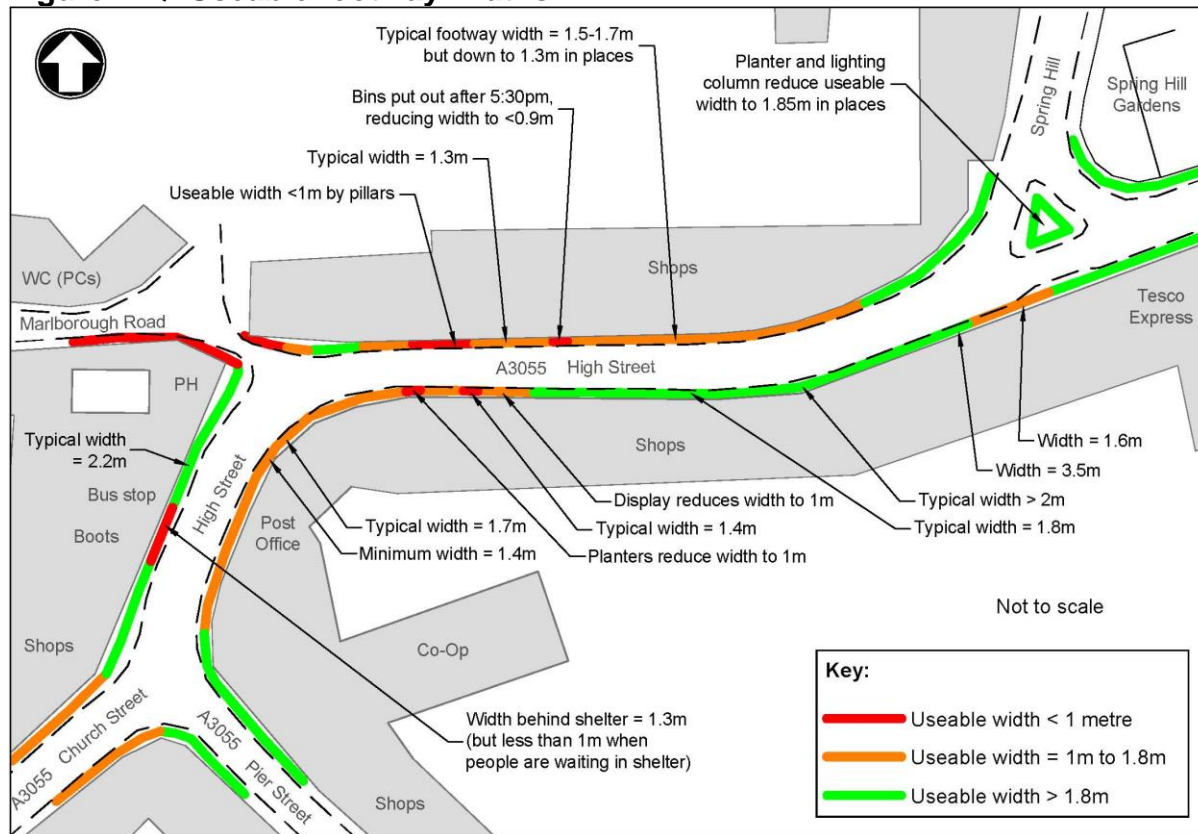
**Figure 2-Q: Useable footway widths**

The red areas on Figure 2-Q show where the most serious 'pinch points' are (footways widths below 1 metre). Other areas of concern are in orange (1m-1.8m wide). The widths themselves should be taken in context with how they are used (see paragraph 2.4.2 ), particularly when assessing accessibility and risk. Figure 2-R shows congestion occurring at one of the relatively wider (2m) sections of footway.

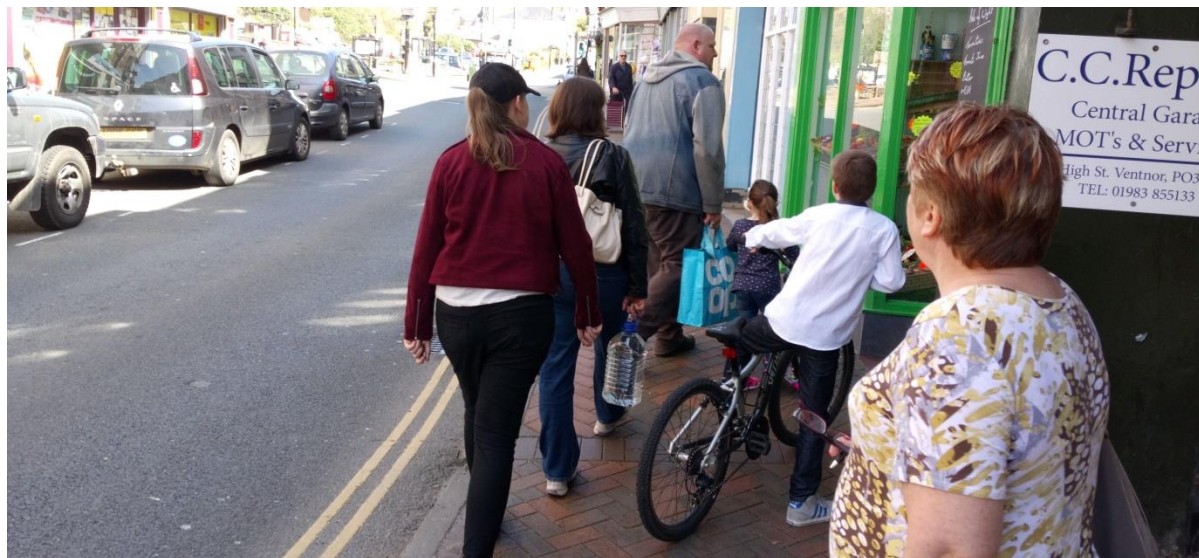
**Figure 2-R: Congestion on the footway**

In addition, the shop frontages open directly onto the footway, which in turn adjoins the road carriageway. On the South side, the cross-fall on the carriageway can make high-sided vehicles 'lean' towards the footway and, along with overhanging appendages such as wing mirrors can impinge on the pedestrian zone, making it feel even narrower and less safe.

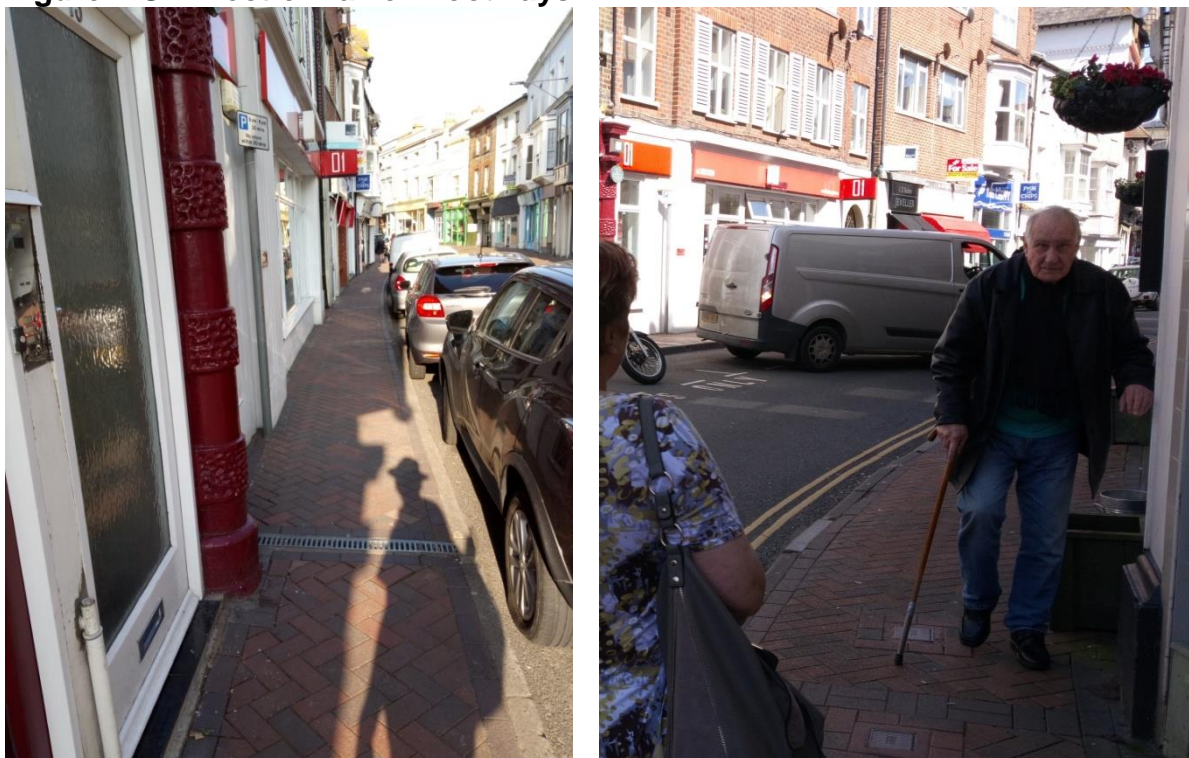
**Figure 2-S: Effect of narrow footways**

The photo on the left of Figure 2-S shows the narrow section of footway on the north side of the High Street where the width reduces from 1.3m to below a metre by the pillars in this shop-front. Open car doors impinge on the meagre space available. Similarly, the photo on the right of Figure 2-S shows the narrow section of footway on the South side of the High Street where the width varies between 1.4 and 1.7m.

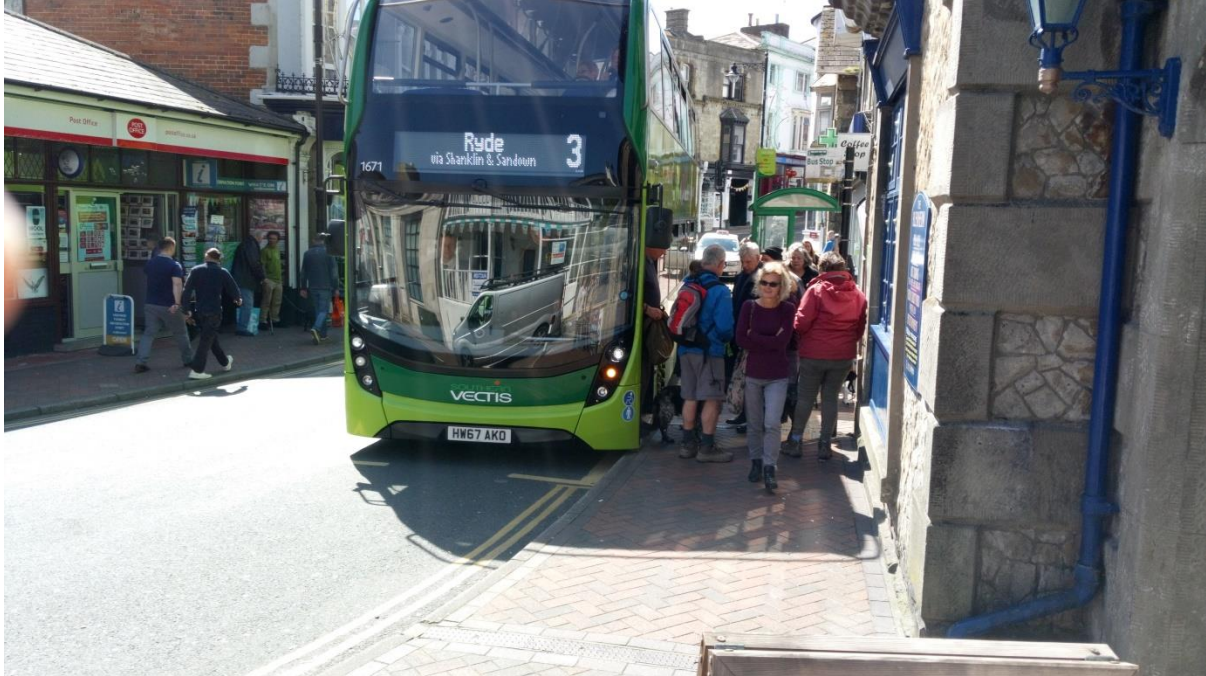
**Figure 2-U: Bus unloading outside Boots**

The footway is impassable when buses are loading / unloading (see Figure 2-U) and we have been told that it causes a problem for local people with visual impairments who are trying to get past.

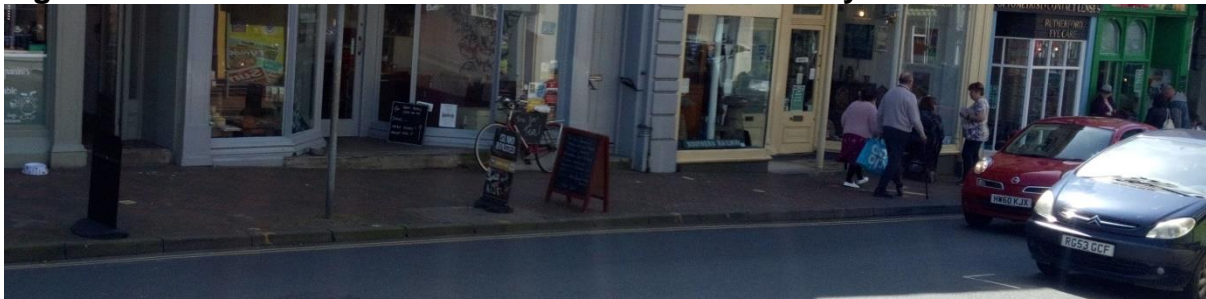
**Figure 2-V: Other moveable obstructions on the footway**

Figure 2-V shows a succession of 'A' boards on the footway, which is approximately 2m wide at this point, but width is further constricted by a bicycle being used as advertising. A visually-impaired person would not be expecting these obstacles and could collide with them. The narrow remaining width would also cause problems for parents with children, persons in larger wheelchairs / mobility scooters and for those using sticks and crutches.

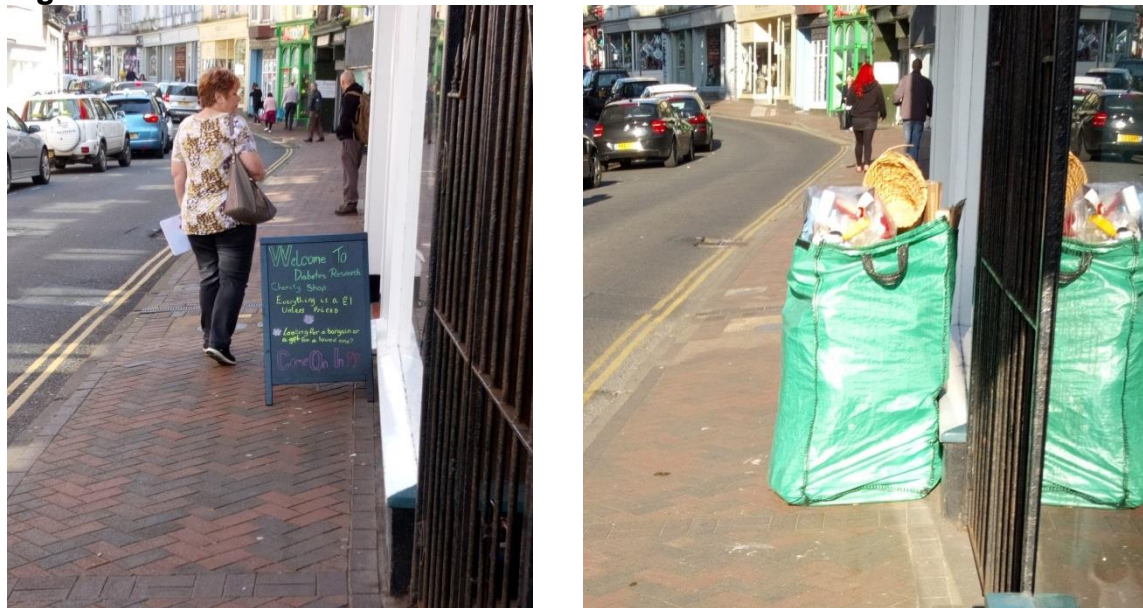
**Figure 2-W: More moveable obstructions**

However, the photograph on the left of Figure 2-W shows an 'A' board which was present on the 17<sup>th</sup> April, and the photo on the right shows a sack which was left on the footway all afternoon during the site visit on the 8<sup>th</sup> May.

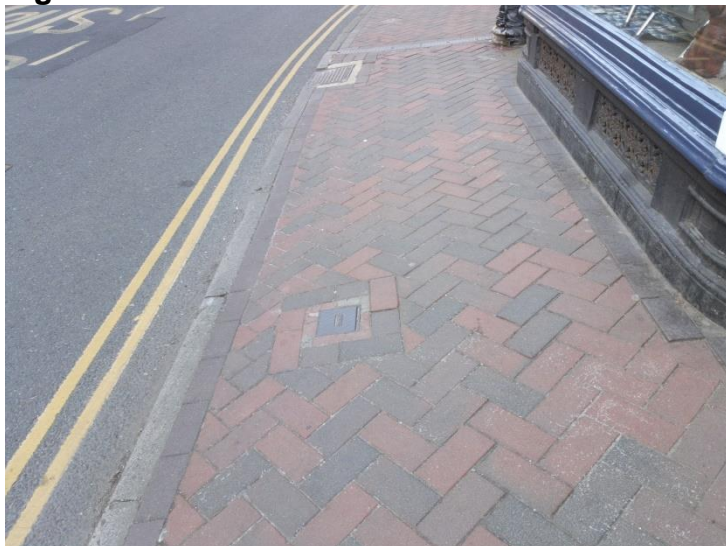
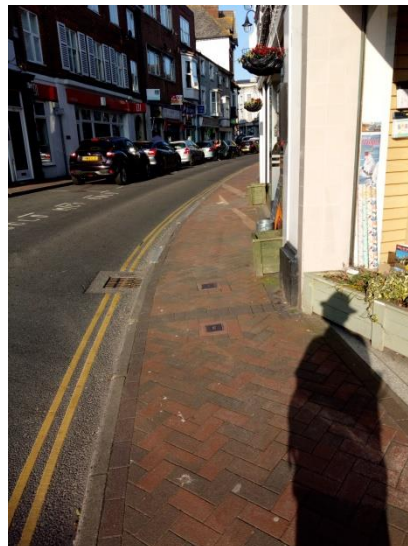
**Figure 2-Y: Excessive cross-falls**

The cross-fall outside Hurst's (Figure 2-Y – left hand photo) is 1:5.5. This is partly because of the slope for the nearby crossing, but the steep cross-fall extends for some way beyond the crossing (recommended max. cross-fall at crossings is 1:12). The cross-fall outside 'Tramezzini' (Figure 2-Y – right photo) is 1:5.8.

Both of these are on very narrow sections of footway and are close to / on a corner.

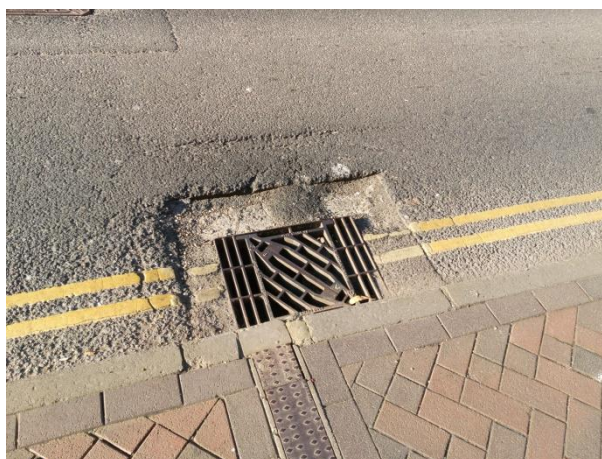
#### **Figure 2-AA: Failed surfacing around drainage gully**

The surfacing issue shown in Figure 2-AA is in the road carriageway, but it adds a further impediment to pedestrians crossing the road. It also causes vehicles to swerve in an attempt to avoid it, or to lean towards the footway when driving over it.

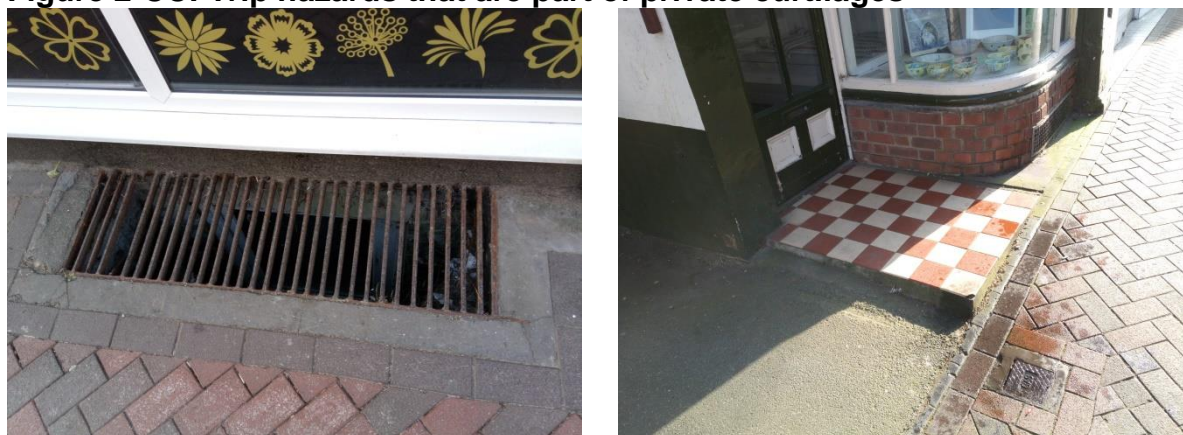
**Figure 2-CC: Trip hazards that are part of private curtilages**

The left-hand photo in Figure 2-CC shows a broken grating, which is partially covered up during business hours when the trader has an external display, but is fully-exposed at other times.

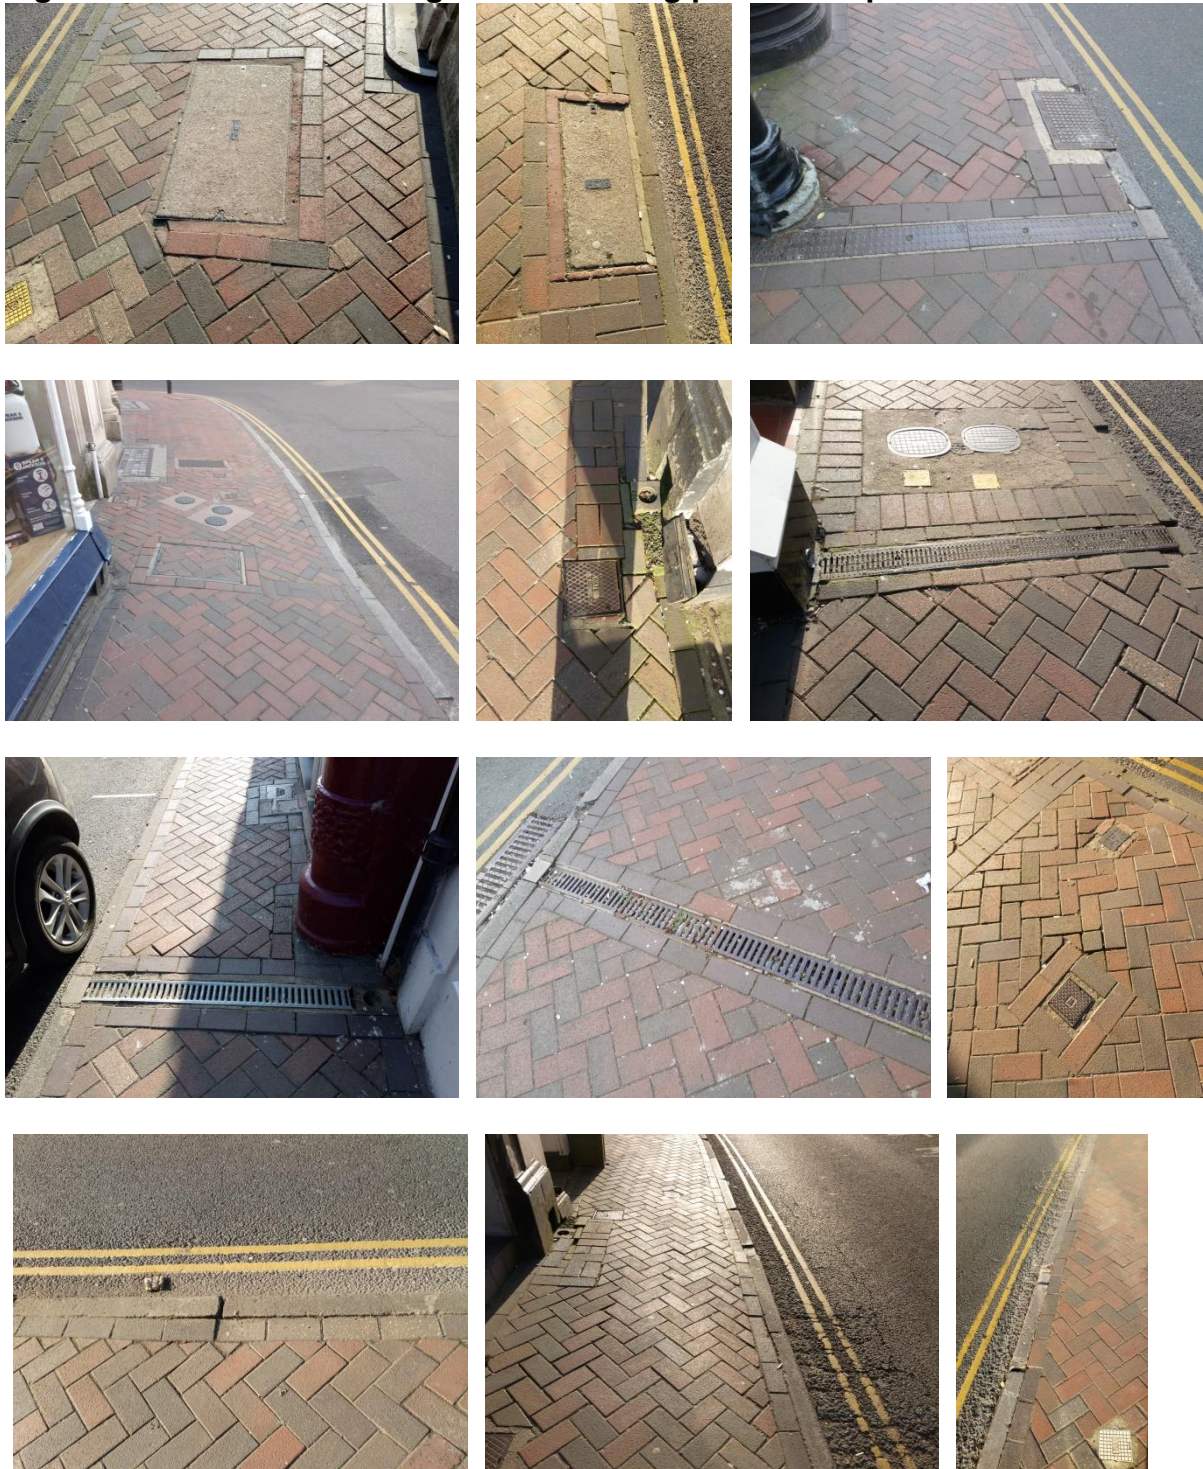
**Figure 2-DD: Other surfacing issues causing potential trip hazards**

There are a few other surfacing issues which are the result of wear and tear on the pavement surface and kerbs, particularly around inspection covers (Figure 2-DD).

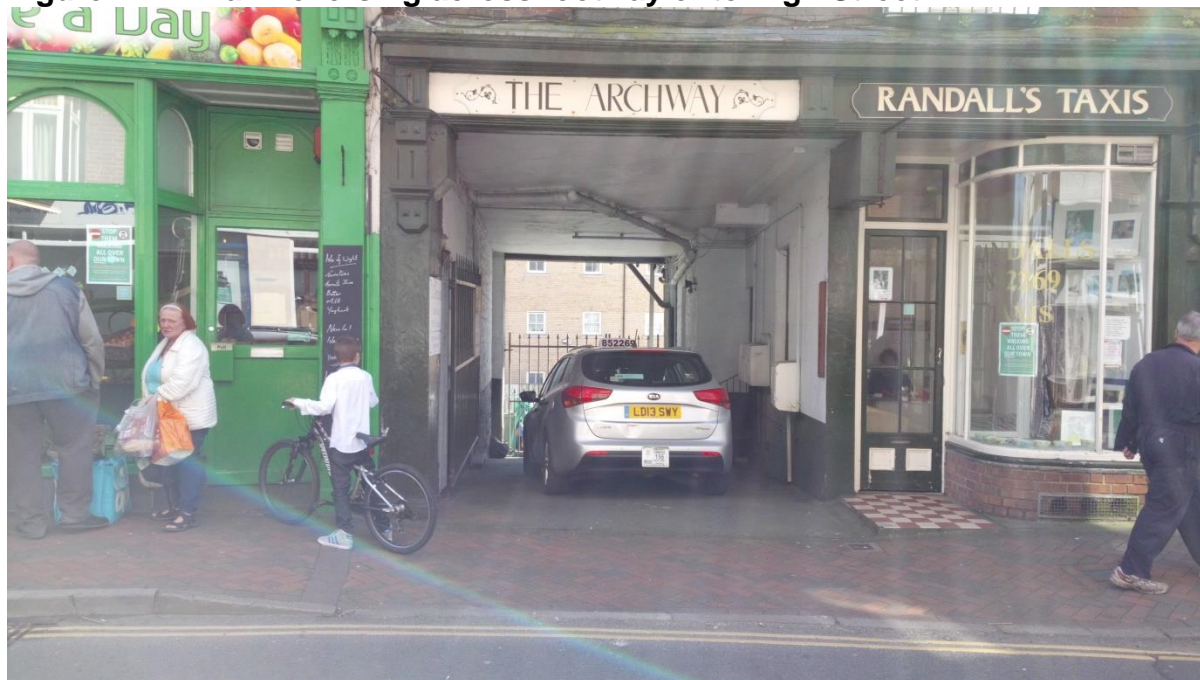
**Figure 2-EE: Taxi reversing across footway onto High Street**

This can be treated as a general safety issue, but it should be borne in mind that persons with sensory impairments may not notice that the vehicle is reversing and those with reduced mobility may struggle to move out of the way quickly enough.
