Accessibility risk assessment of Ventnor High Street

for
Ventnor Town Council

May 2018

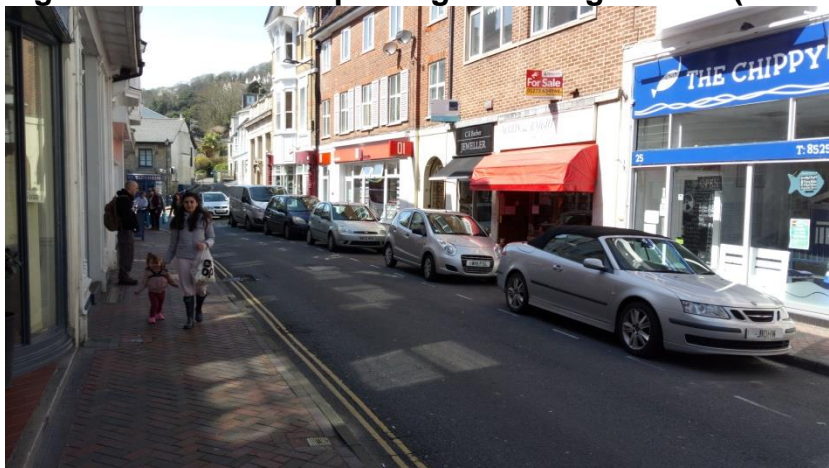
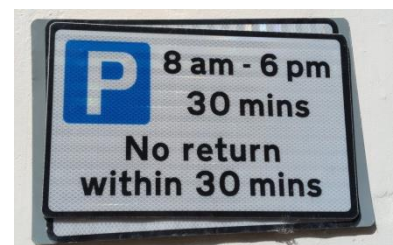
Figure 2-B: On-street parking in the High Street (short-stay)

There are no designated 'blue badge' ('disabled') parking bays here. This does not preclude disabled vehicle drivers and passengers from using these bays, but their usability will depend upon an individual's own access requirements. There is also space for solo motorcycles here.

There are no accessible pedestrian crossing facilities in this section of the High Street (see Paragraph 2.3.4). Nor are there any dropped kerbs (save for the vehicle cross-over at The Archway on the opposite side). The street is one way, therefore only the passenger's ('near') side will have direct access onto the footway.

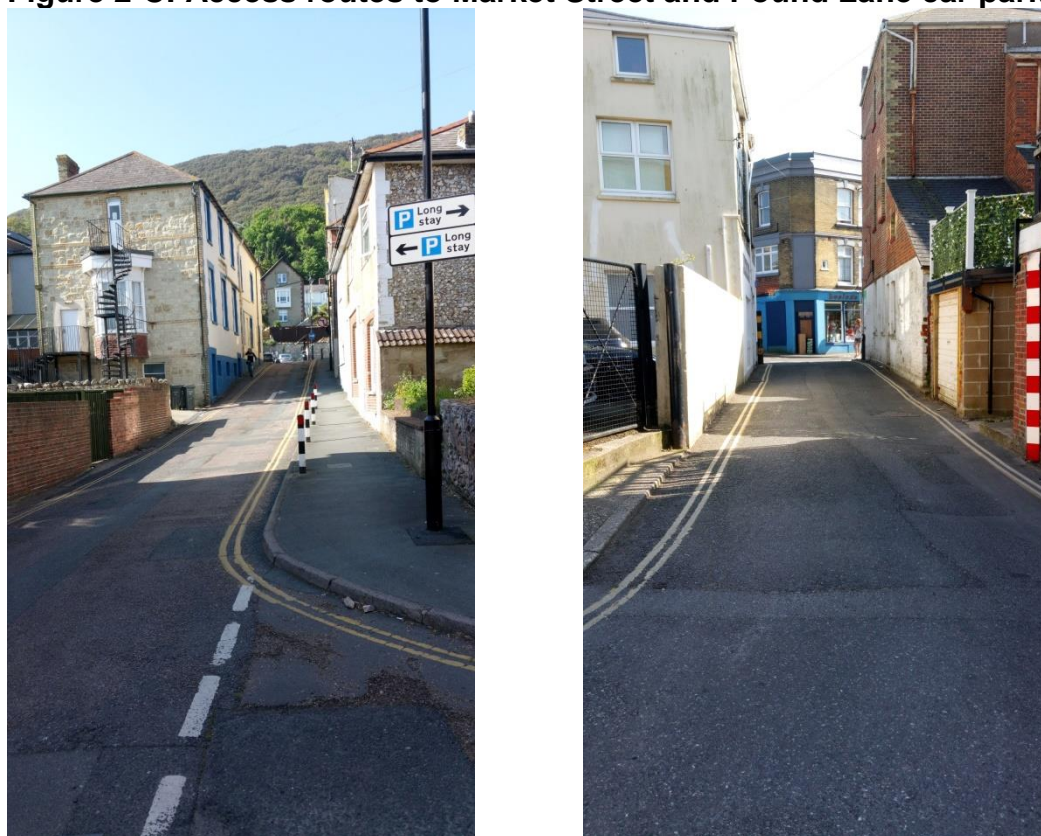
Figure 2-C: Access routes to Market Street and Pound Lane car parks

Whichever route they take, pedestrians (including wheelchair users and other vulnerable people) will be required to walk in the road for part of their journey to the High Street from either of these car parks. In some areas, the road surface is in poor condition, presenting further problems to those with mobility difficulties.

Depending on the nature of a person's impairment and also on their ultimate destination within the town centre, the issues with connectivity / accessibility of the routes to the Pound Lane / Market Street car parks could limit their suitability as parking for those visiting / using the High Street itself.

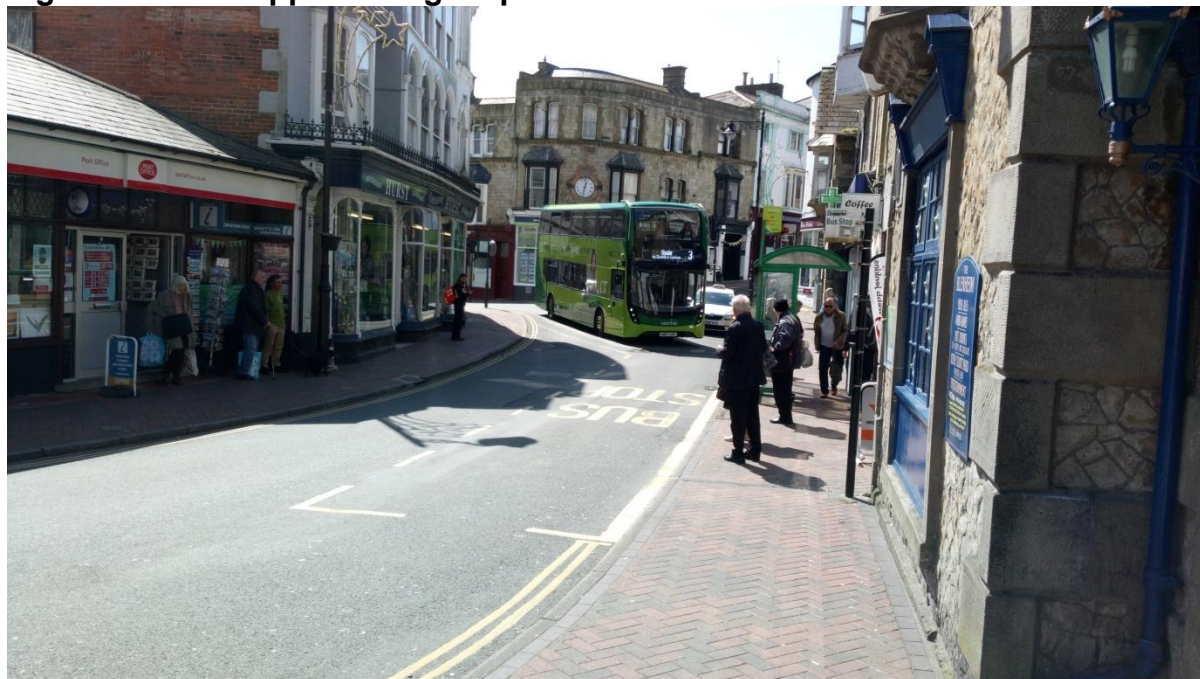
Figure 2-F: Bus approaching stop outside Boots

This means that buses cannot pull up parallel with the kerb at the front of the stop. The importance of pulling level with the kerb is explained in Paragraph 2.2.6 , including its relevance to accessibility.

Our site visits observed many buses arriving and departing from this stop: only the smaller vehicles used on the No. 31 and the 6 were able to pull in properly, whereas the larger vehicles used on the No. 3 could not. There were a number of occasions when two buses were using the stop simultaneously, although the stop is only long enough to accommodate one maximum length (12m) bus.

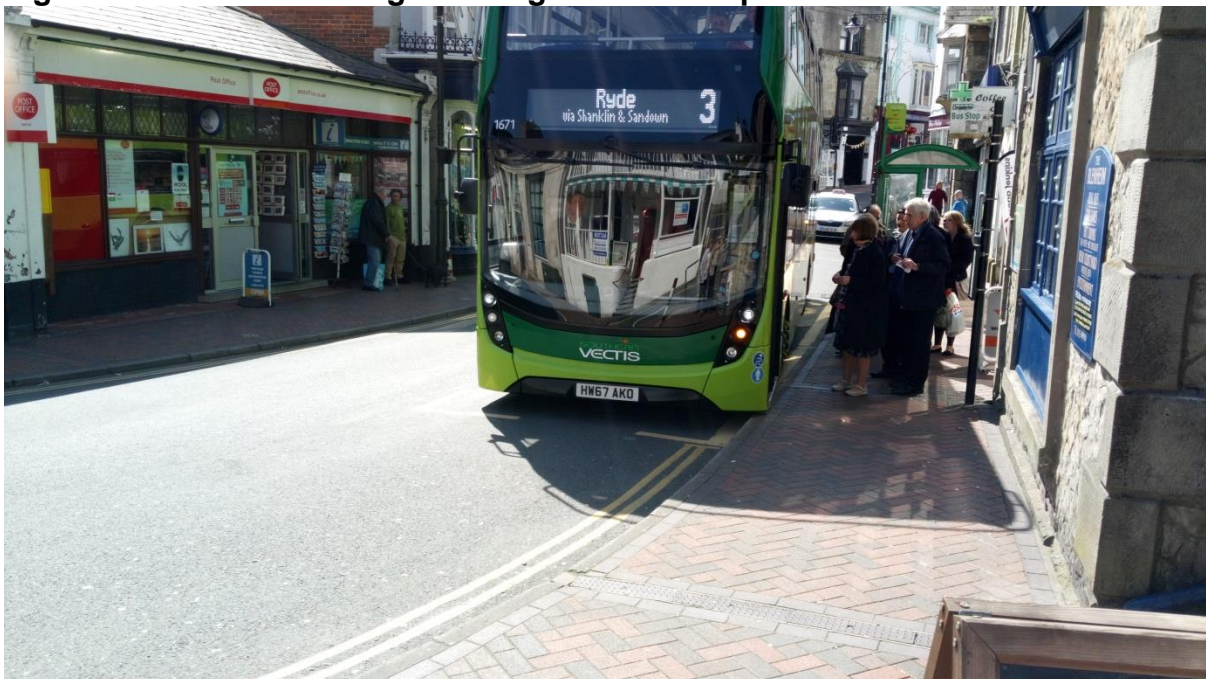
Figure 2-G: Bus unloading / loading at Boots stop

Using the bus's ramp, there needs to be adequate footway width for a person using either a self-propelled manual wheelchair or an electric wheelchair to board or alight from the bus.

However, for those using either a manual wheelchair (being pushed from behind) or a Class 2 mobility scooter (which has a longer wheel-base and larger turning circle) the current footway width may be insufficient and needs to be investigated further.

Accessibility for passengers boarding or alighting from the bus can also be compromised by congestion caused by the sheer volume of people on the footway (as illustrated in Figure 2-G and in Figure 2-U).

This bus stop does not have a raised kerb. Installing a raised kerb would have a limited benefit at this location and would almost certainly cause more problems with a net reduction in accessibility (see Paragraph 2.2.6). Therefore we would advise against installing a raised kerb unless the bus stop and its approaches are to be redesigned to allow buses to pull in completely straight.

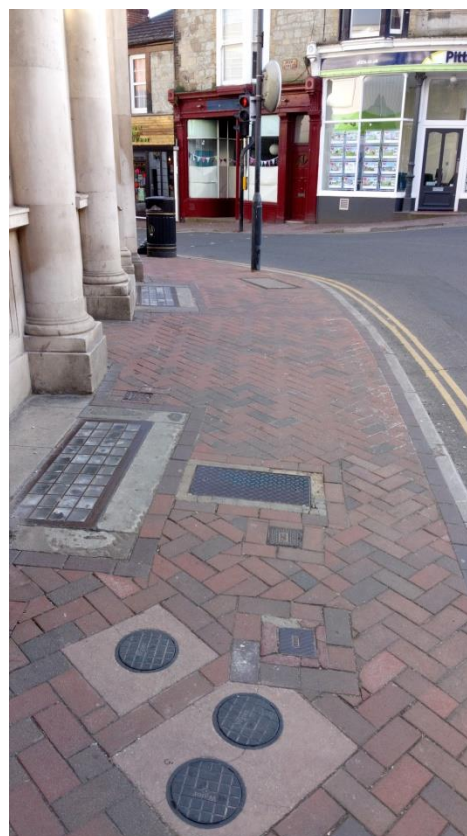
Crossing C3 is uncontrolled, therefore a pedestrian waiting on the East side of Crossing C3 would need to be able to discern traffic

approaching from Church Street and / or Pier Street.

Figure 2-L shows the view towards Pier Street from this point. Clear visibility between the crossing and the main carriageway of Pier Street is restricted to approximately 17 metres and, depending on the phase / stage of the traffic signals, may not be enough to give drivers approaching from Pier Street sufficient stopping sight distance to see pedestrians crossing the road here (and vice-versa).

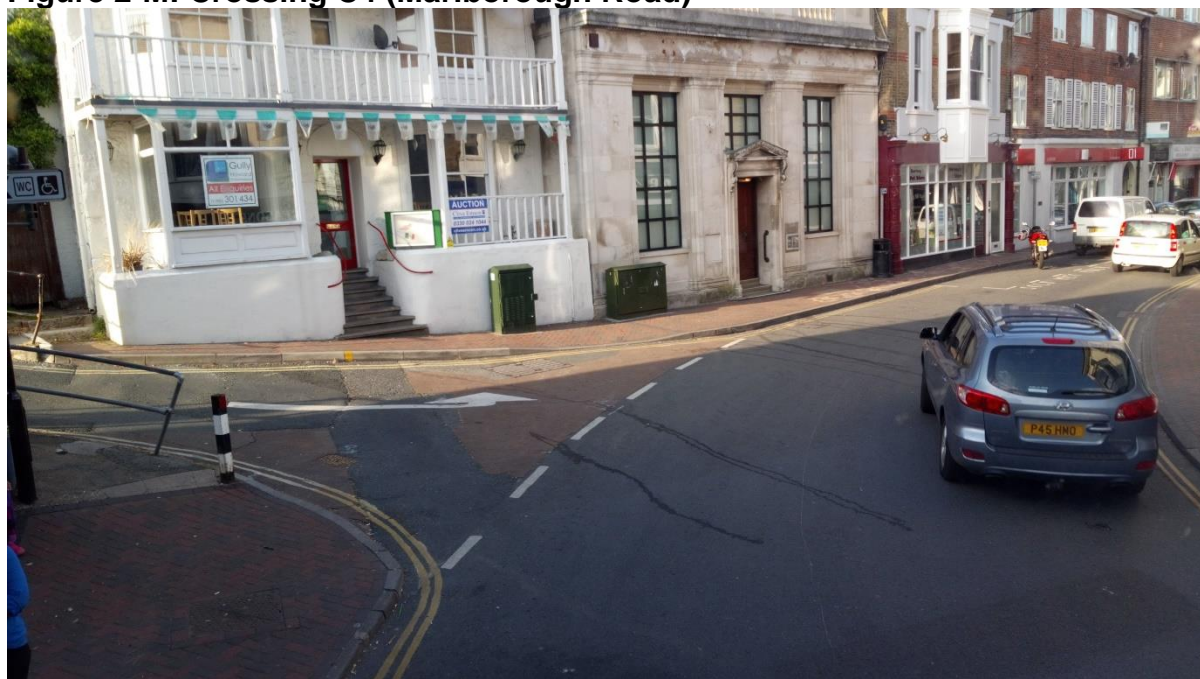
Figure 2-M: Crossing C4 (Marlborough Road)

There is no tactile paving on either side of the crossing to warn VI pedestrians that they are walking across a side road, or to align them with the opposite footway.

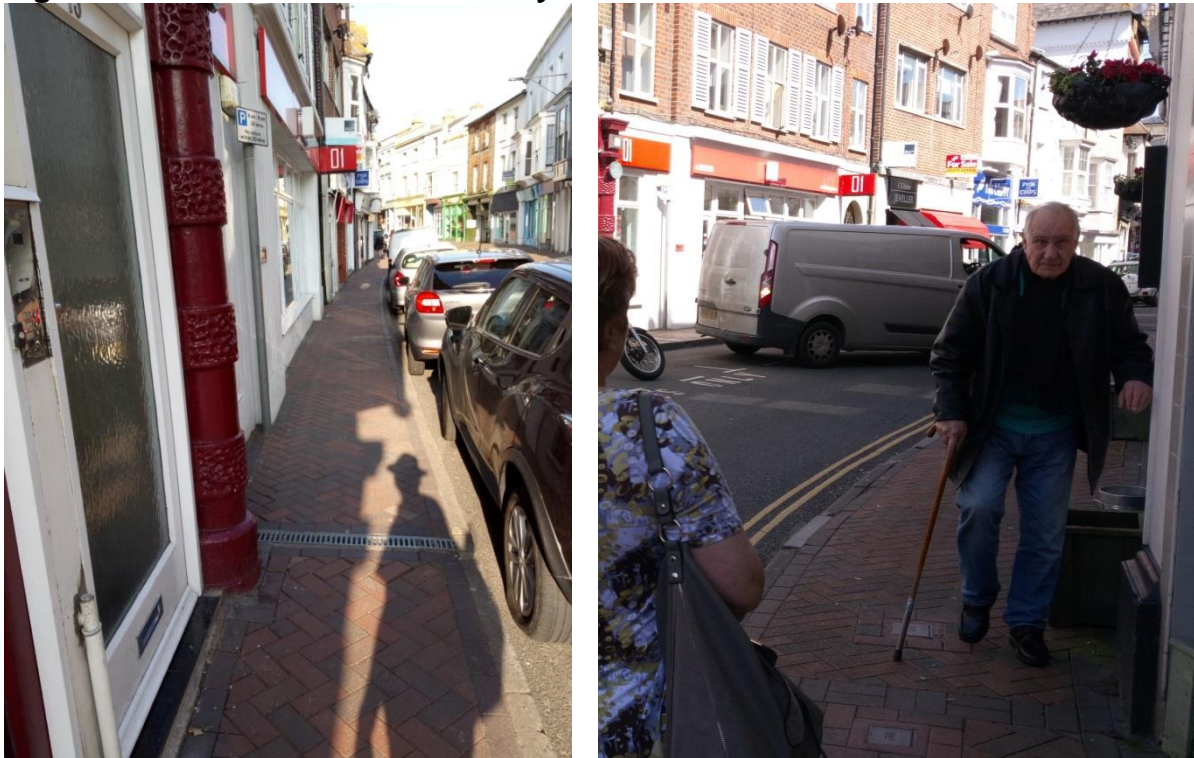
Figure 2-S: Effect of narrow footways

The photo on the left of Figure 2-S shows the narrow section of footway on the north side of the High Street where the width reduces from 1.3m to below a metre by the pillars in this shop-front. Open car doors impinge on the meagre space available. Similarly, the photo on the right of Figure 2-S shows the narrow section of footway on the South side of the High Street where the width varies between 1.4 and 1.7m.

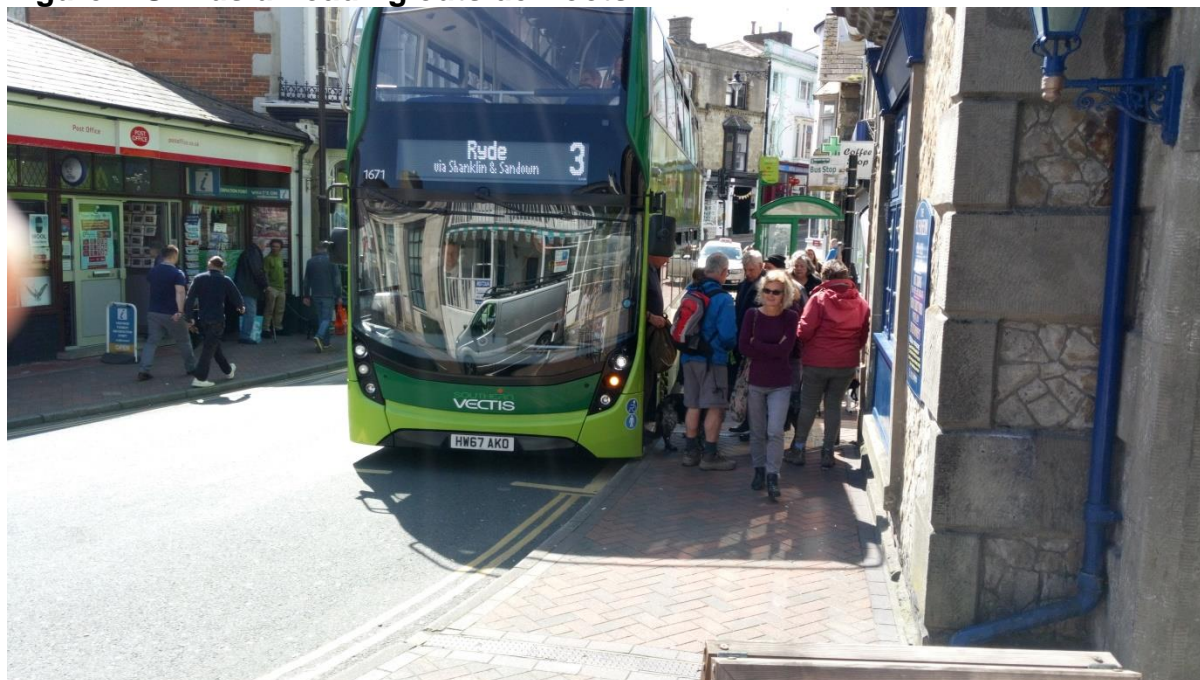
Figure 2-U: Bus unloading outside Boots

The footway is impassable when buses are loading / unloading (see Figure 2-U) and we have been told that it causes a problem for local people with visual impairments who are trying to get past.

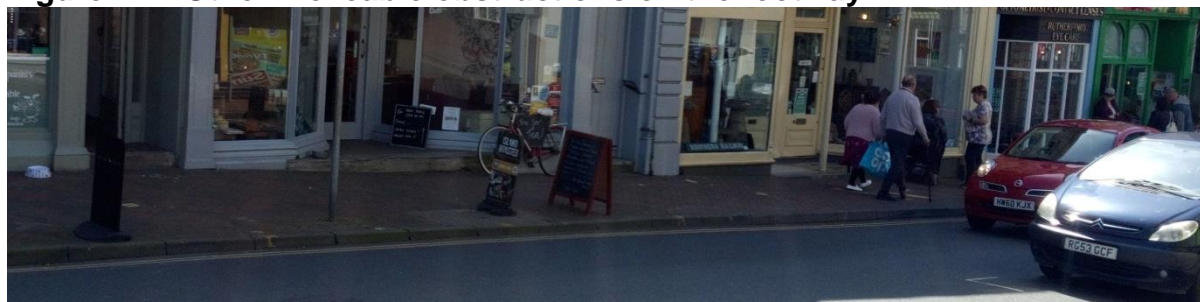
Figure 2-V: Other moveable obstructions on the footway

Figure 2-V shows a succession of 'A' boards on the footway, which is approximately 2m wide at this point, but width is further constricted by a bicycle being used as advertising. A visually-impaired person would not be expecting these obstacles and could collide with them. The narrow remaining width would also cause problems for parents with children, persons in larger wheelchairs / mobility scooters and for those using sticks and crutches.

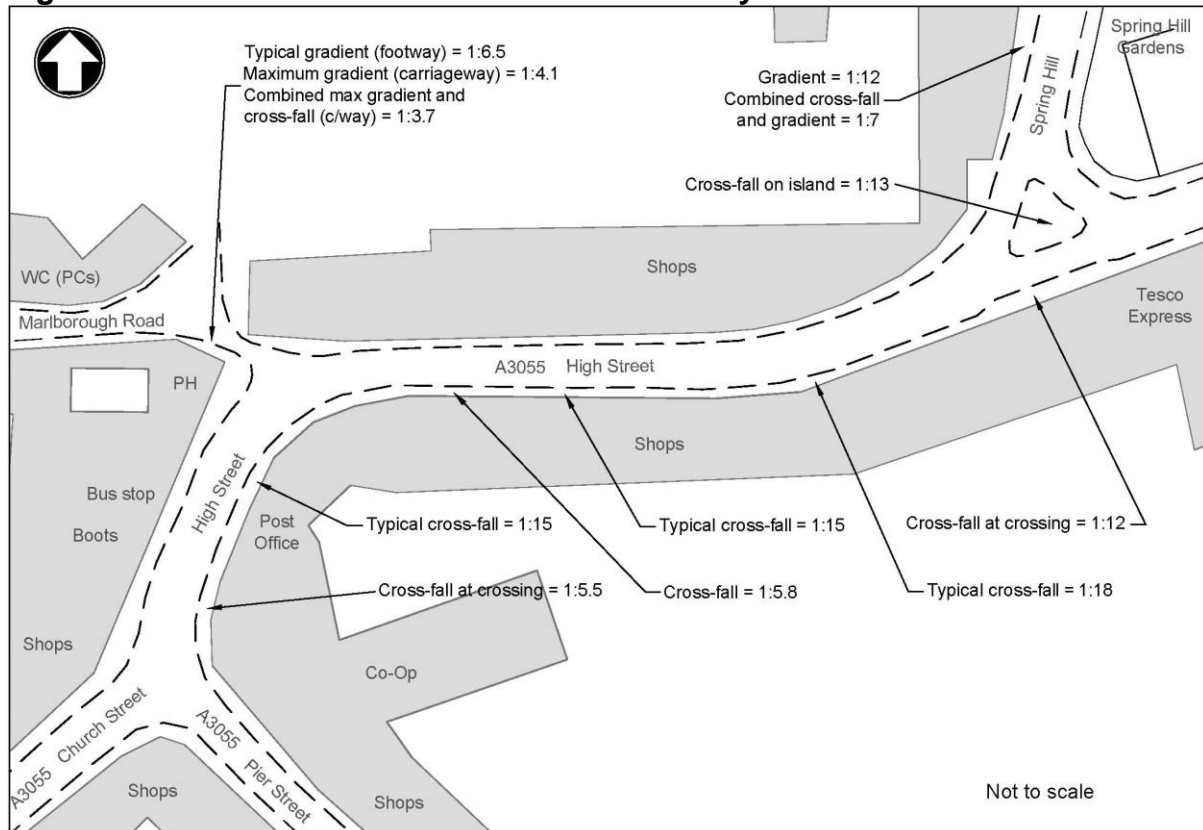
Figure 2-X: Gradients and cross-falls in the study area

Typical cross-falls on the footways in much of Ventnor High Street are around 1:15 – 1:20, which are manageable for the majority of users. The more severe cross-falls are located on the South side of the High Street (see Figure 2-X and Figure 2-Y).

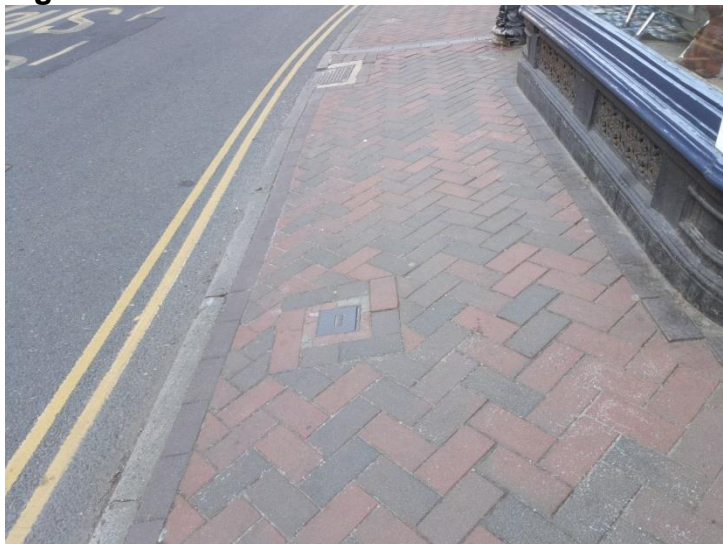
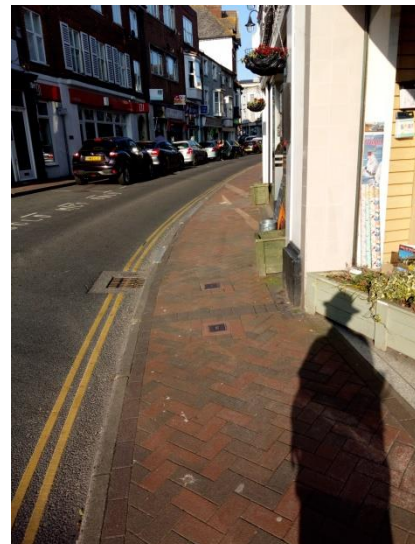
Figure 2-Y: Excessive cross-falls

The cross-fall outside Hurst's (Figure 2-Y – left hand photo) is 1:5.5. This is partly because of the slope for the nearby crossing, but the steep cross-fall extends for some way beyond the crossing (recommended max. cross-fall at crossings is 1:12). The cross-fall outside 'Tramezzini' (Figure 2-Y – right photo) is 1:5.8.

Both of these are on very narrow sections of footway and are close to / on a corner.

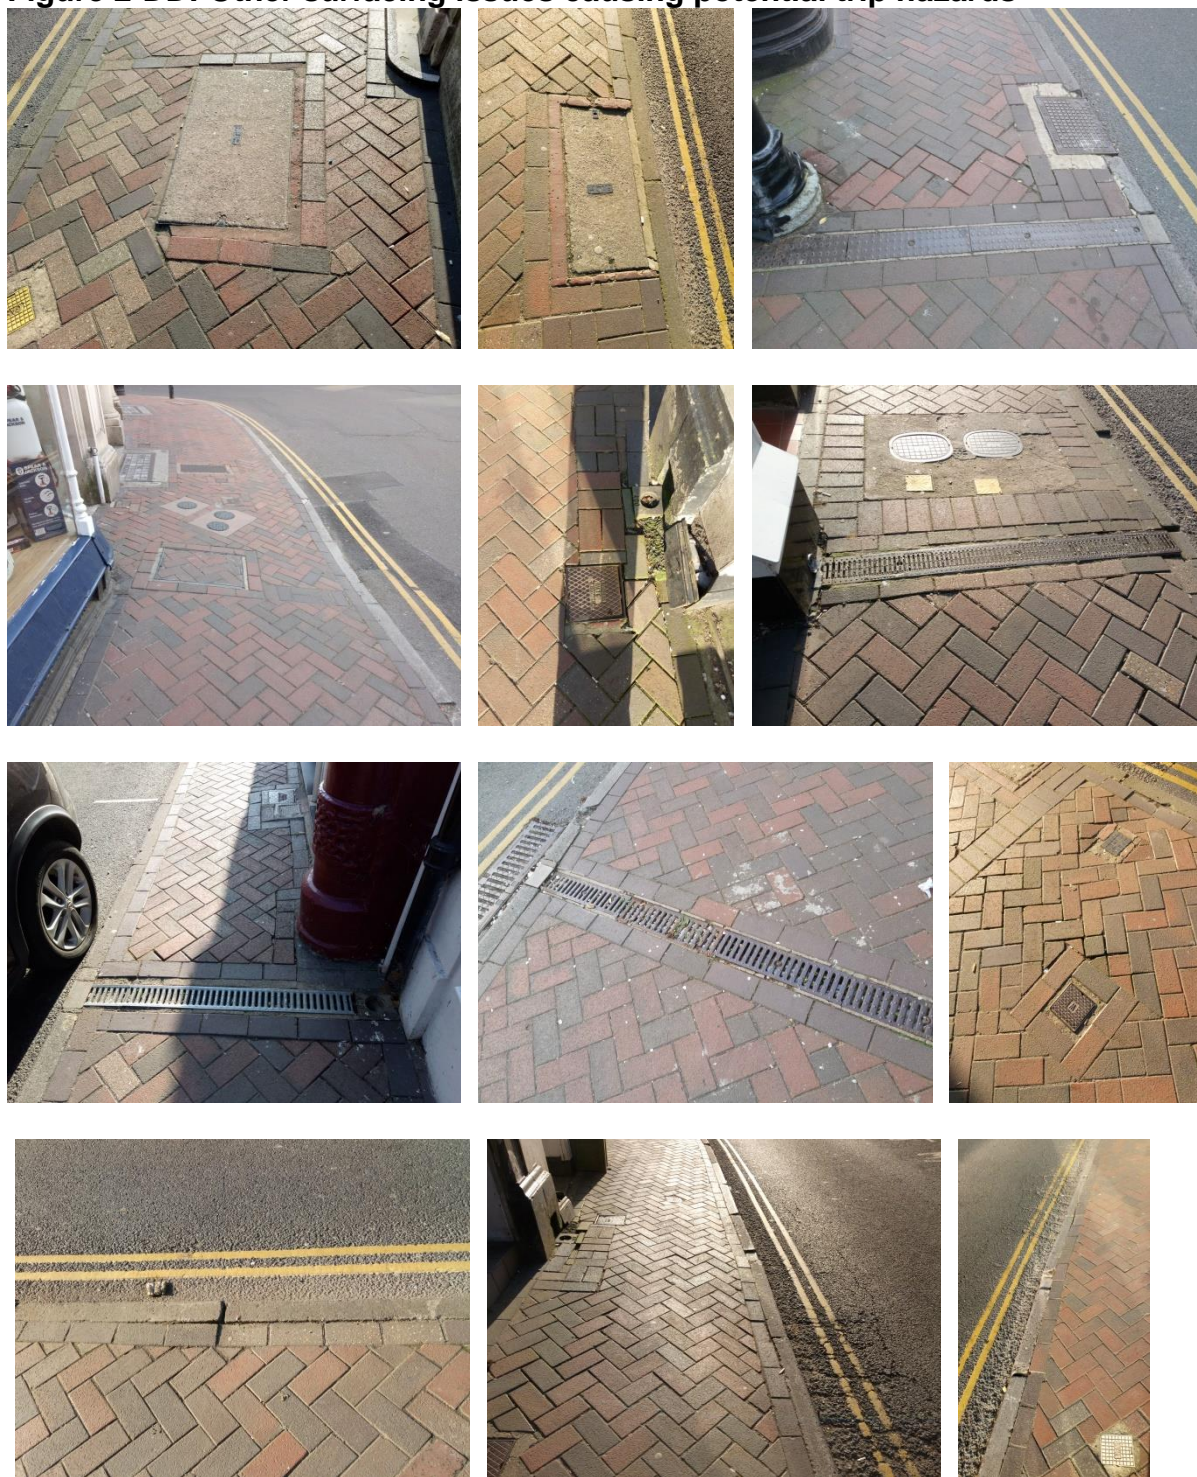
Figure 2-DD: Other surfacing issues causing potential trip hazards

There are a few other surfacing issues which are the result of wear and tear on the pavement surface and kerbs, particularly around inspection covers (Figure 2-DD).
