TOWN COUNCIL MEETING

REPORT 32/19

The purpose of this Report is to ask Members to consider the Isle Access Report on the accessibility risks of the Salisbury Gardens' Green and a consequent recommendation of the Assets and Services Working Group about Ventnor Day 2019.

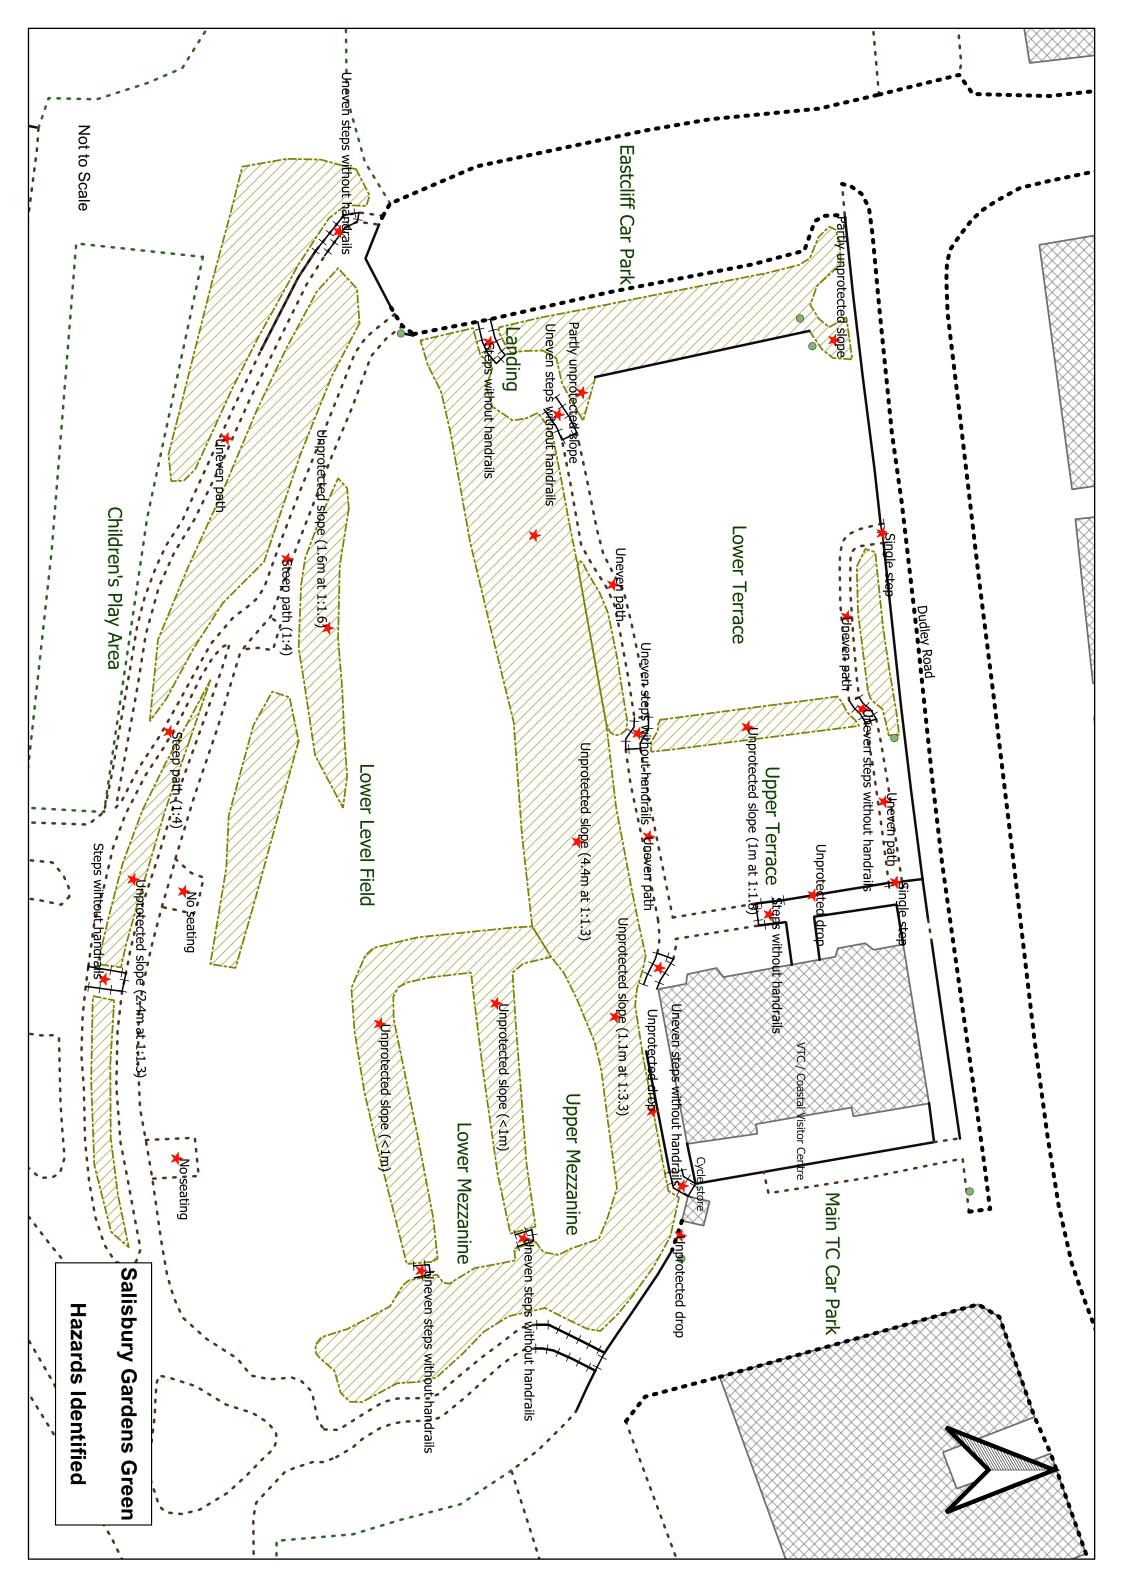
Issues are picked out with a red star and labelled in black on the 'Hazards Identified' plan.

Only the Lower Level Field has step-free access.

This makes much of the site inaccessible to users of 'personal mobility devices' ('PMDs') such as wheelchairs and mobility scooters.

The entire site is characterised by a series of landscaped terraces separated by embankments (earthworks) with heights varying between 0.5m and 4.4m, and slopes varying between 30% (1:3.3) and 75% (1:1.3).

None of the other drops are protected, presenting a potential falling hazard to those with low vision or poor mobility. These are identified on the plan.

There is also a steep ridge along part of the southern edge of the Lower Level Field down to the footpath, as well as the embankment between the footpaths.

In addition, there is a section of unprotected low wall near to the entrance of the Town Council / Coastal Visitor Centre building. Any vision-impaired persons on the grassed area of the Upper Terrace might not be able to detect this.

In the Upper and Lower Terraces, the paths consist of stone slabs laid directly in the grass. These are uneven and are not only a trip hazard but also provide insufficient surface for many PMD users.

There are 14 sets / flights of steps / stairs within or adjacent to the site. Most are of inconsistent rise / tread (height / depth) and are uneven (especially those in and around the Upper and Lower Terraces), all but one are also lacking handrails.

The main path running from the Eastcliff Car Park along the South edge of the Lower Level Field has steep sections with a gradient up to 1:4. There is no handrail here.
