# **Accessibility risk assessment of Ventnor High Street**

for  
Ventnor Town Council

May 2018

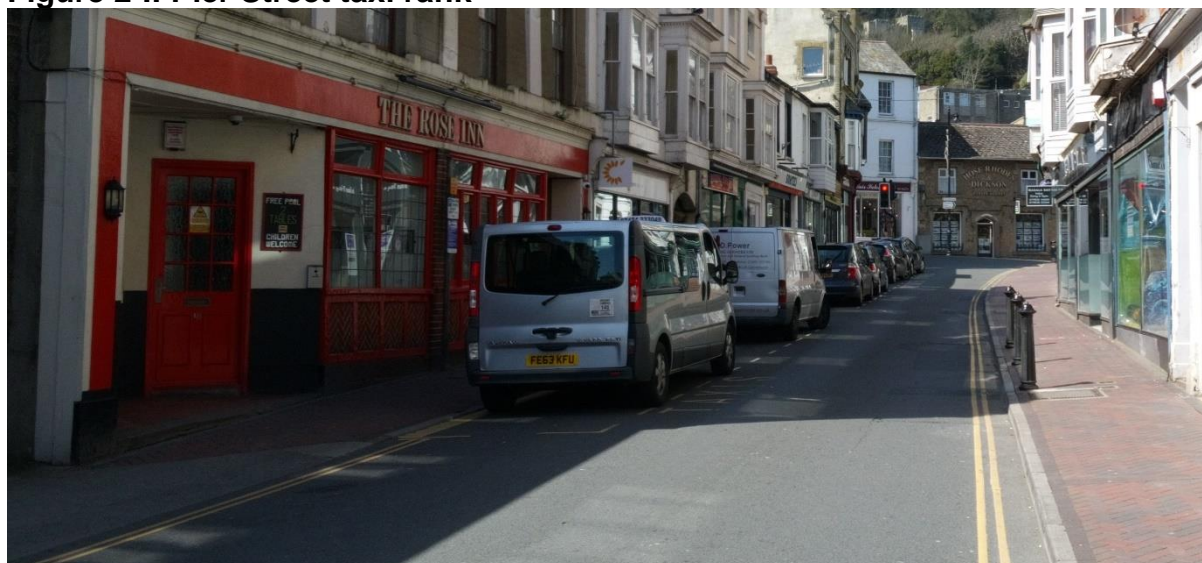
**Figure 2-I: Pier Street taxi rank**

The only limitation is that this rank has no sheltered waiting facilities (although some patrons wait under the nearby canopy of the former bus garage). Visibility of traffic coming around the corner from Albert Street may also be an issue, but we advise discussing with local taxi firms when ascertaining the level of risk.

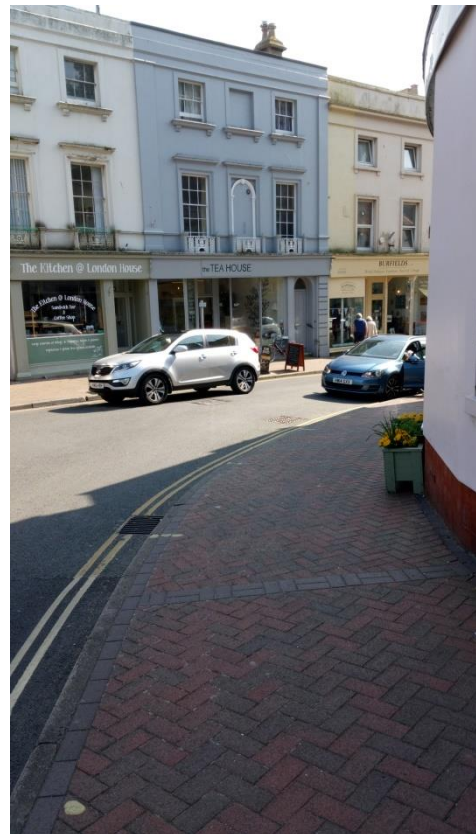
As with Crossing C3, this has an effect on the safe usability of the crossing for all pedestrians, especially for those with mobility difficulties who may need extra time to cross.

Unlike C3, there are no practical alternative crossing facilities nearby.

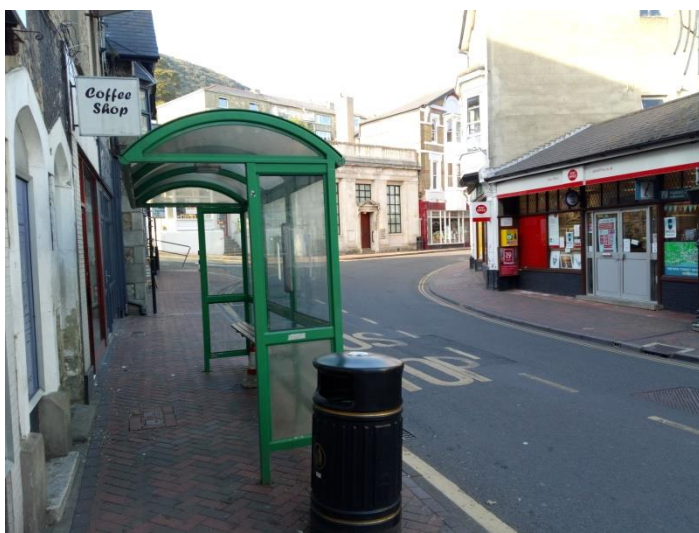
**Figure 2-T: Main bus stop**

Figure 2-T (right) shows the bus stop outside Boots - in a very rare (and brief) quiet period! The footway width is typically 2.2m here, but the bus shelter constricts the available width to 1.3m. This is reduced when waiting passengers are sat in the shelter, and reduced even further when waiting passengers are standing by the shelter.

The footway is impassable when buses are loading / unloading (see Figure 2-U) and we have been told that it causes a problem for local people with visual impairments who are trying to get past.

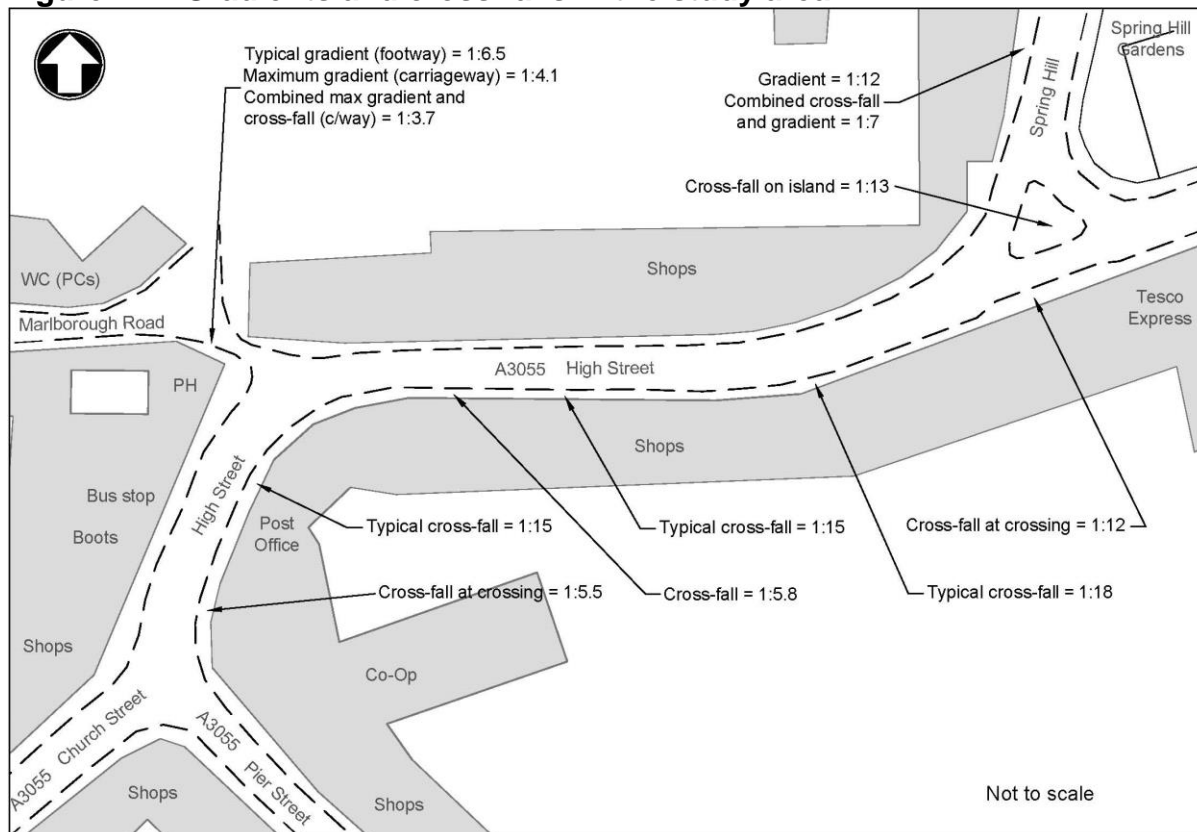
**Figure 2-X: Gradients and cross-falls in the study area**

Excessive cross-falls can also be a problem for those walking, especially in poor weather (e.g. when covered in mud, ice or running water), causing a slip hazard.

Typical cross-falls on the footways in much of Ventnor High Street are around 1:15 – 1:20, which are manageable for the majority of users. The more severe cross-falls are located on the South side of the High Street (see Figure 2-X and Figure 2-Y).

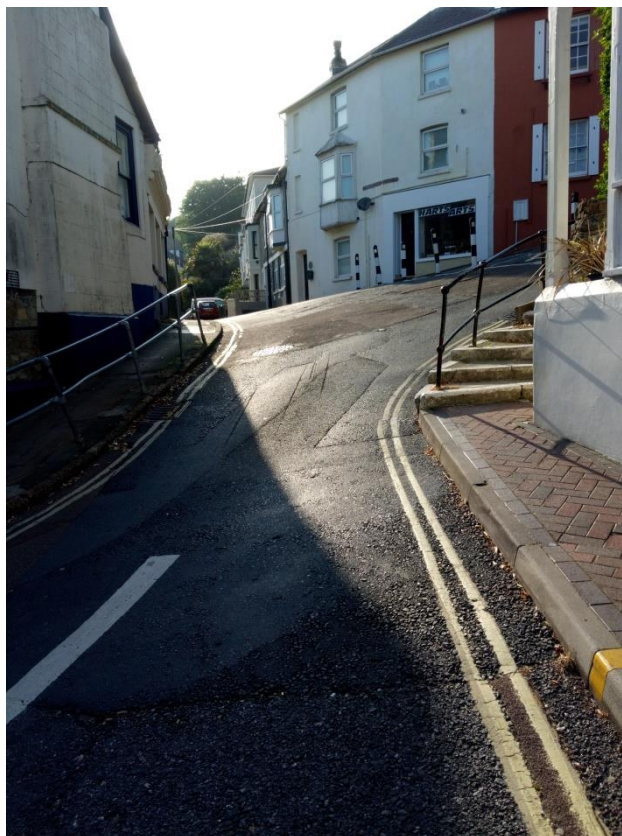
In reality, this is caused by the topography of Ventnor and cannot easily be remedied.

There are handrails between the footway and the road.

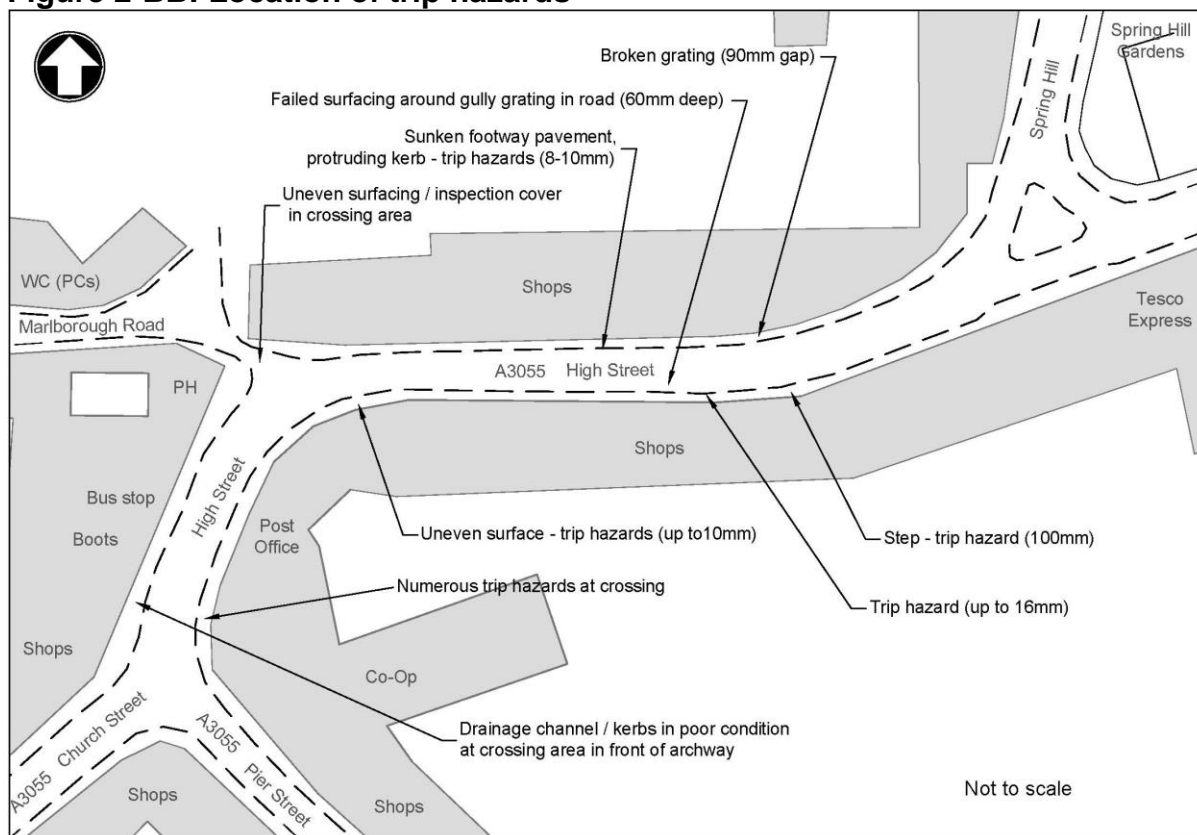
**Figure 2-BB: Location of trip hazards**

The location of this and other trip hazards are shown in Figure 2-BB.

Some of these trip hazards are related to the private premises adjacent to the footways.

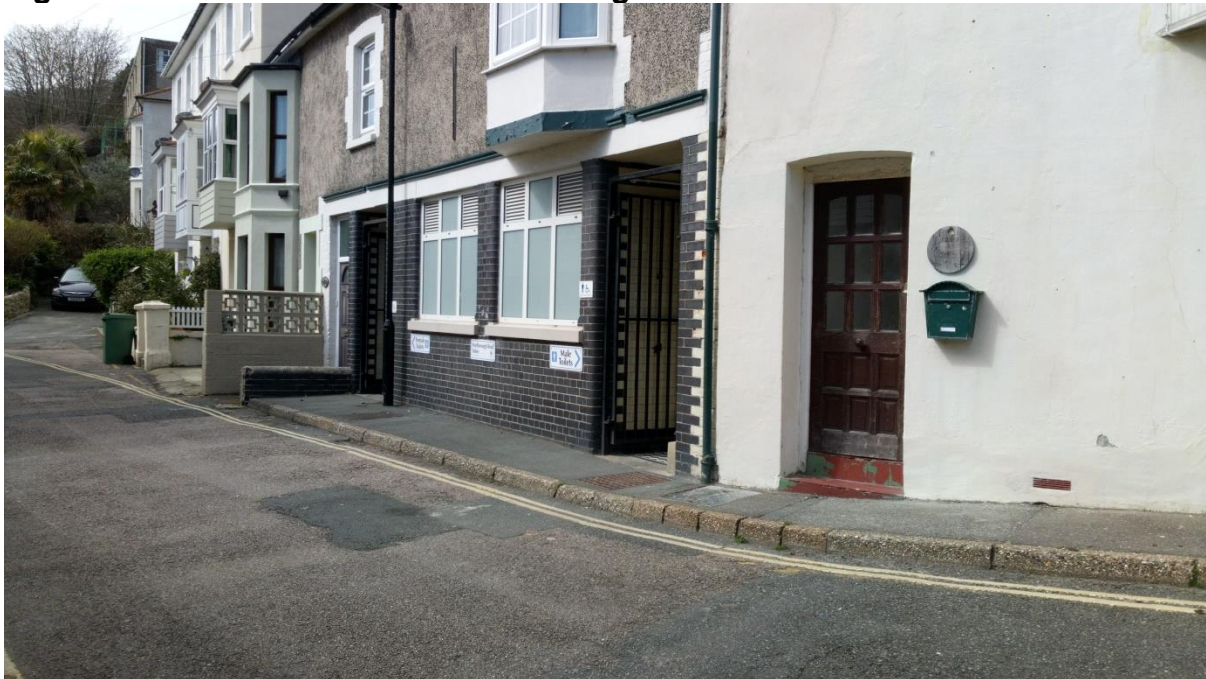
**Figure 2-FF: Public toilets on Marlborough Road**

The narrow footway, inset inspection covers and road carriageway cross-fall away from the toilets make this a difficult situation to resolve cheaply or sensitively.

NB the footway on the South side of Marlborough Road (which leads up from the High Street – see Figure 2-Z) has no pedestrian dropped kerb, but does have a vehicle crossover (opposite the toilet building) with a 65mm upstand (which cannot be described as ‘step-free’)

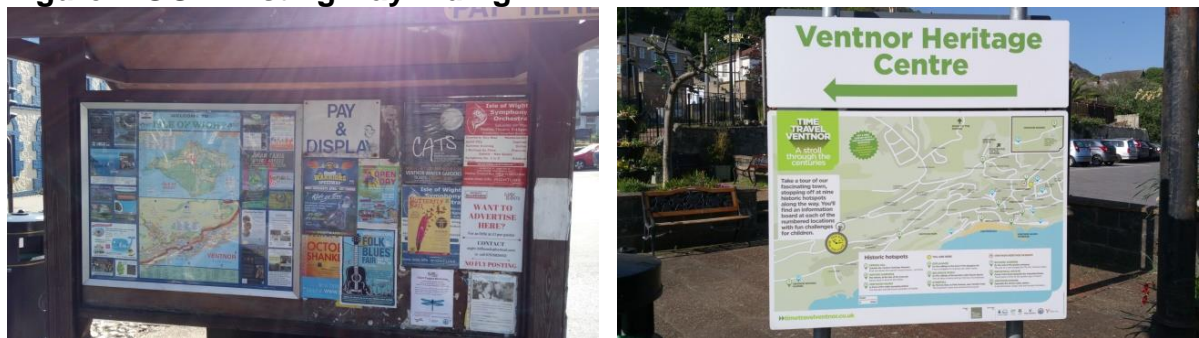
**Figure 2-GG: Existing wayfinding**

However, there is a general lack of clear plans and signage directing people to the High Street shopping area and to the car parks etc. There is no specific 'accessibility' information.
