Accessibility risk assessment of Ventnor High Street

for
Ventnor Town Council

May 2018

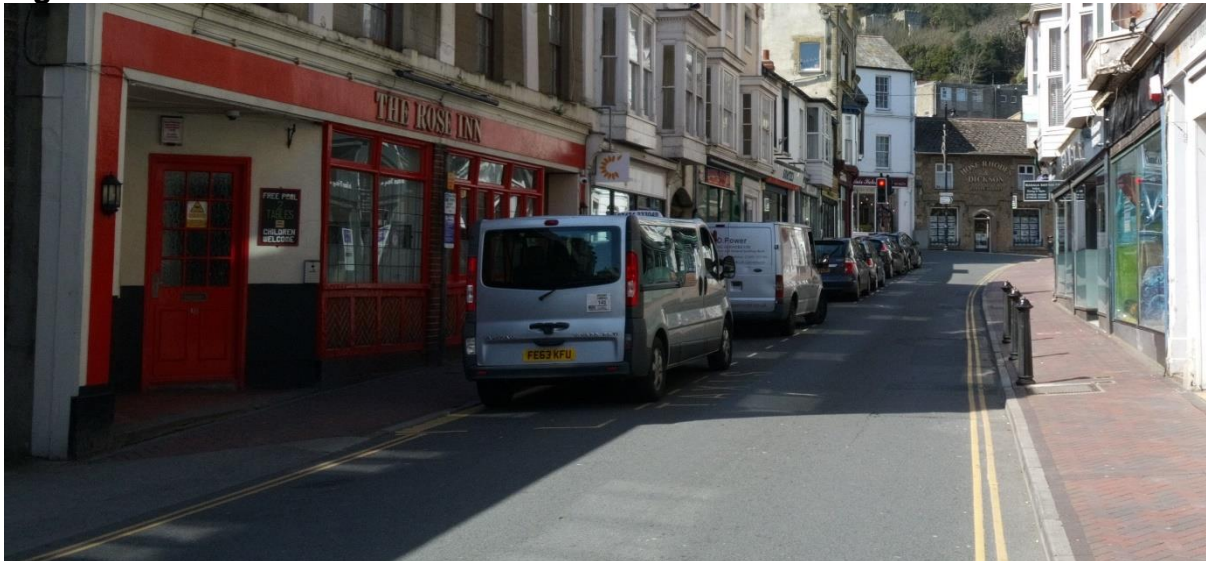
Figure 2-I: Pier Street taxi rank

The only limitation is that this rank has no sheltered waiting facilities (although some patrons wait under the nearby canopy of the former bus garage). Visibility of traffic coming around the corner from Albert Street may also be an issue, but we advise discussing with local taxi firms when ascertaining the level of risk.

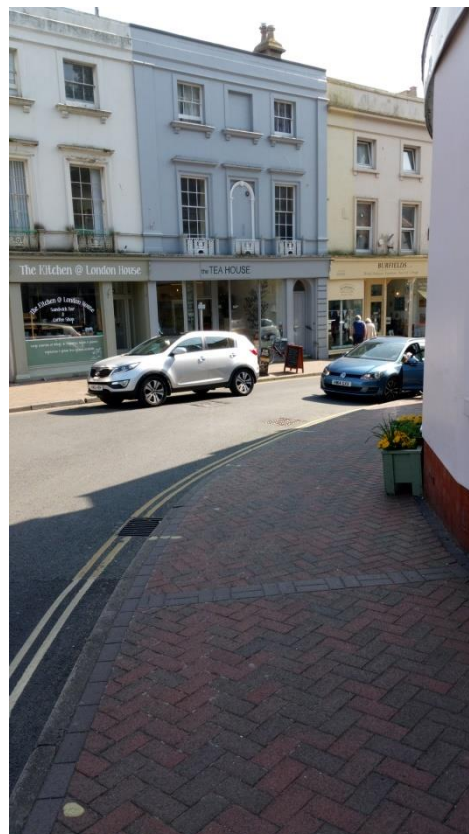
As with Crossing C3, this has an effect on the safe usability of the crossing for all pedestrians, especially for those with mobility difficulties who may need extra time to cross.

Unlike C3, there are no practical alternative crossing facilities nearby.

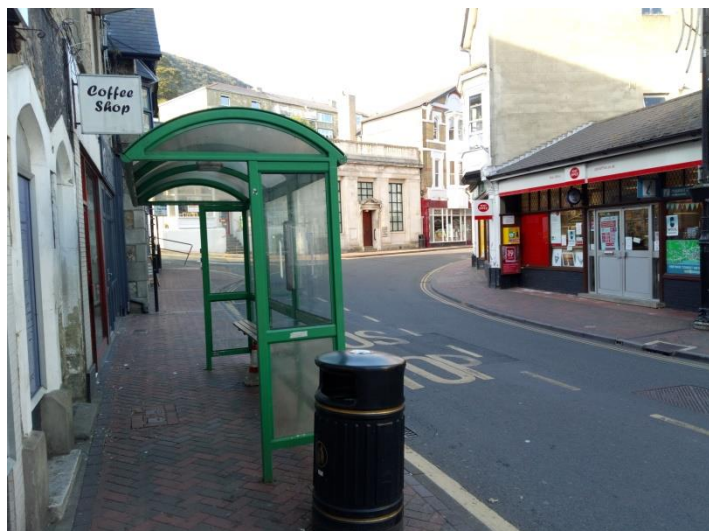
Figure 2-T: Main bus stop

Figure 2-T (right) shows the bus stop outside Boots - in a very rare (and brief) quiet period! The footway width is typically 2.2m here, but the bus shelter constricts the available width to 1.3m. This is reduced when waiting passengers are sat in the shelter, and reduced even further when waiting passengers are standing by the shelter.
