VENTNOR CENTRAL: CURRENT USAGE

REPORT 91/19

VENTNOR YOUTH CENTRE BUILDING
VICTORIA STREET
VENTNOR
ISLE of WIGHT PO38 1ET

FIRE SAFETY REPORT

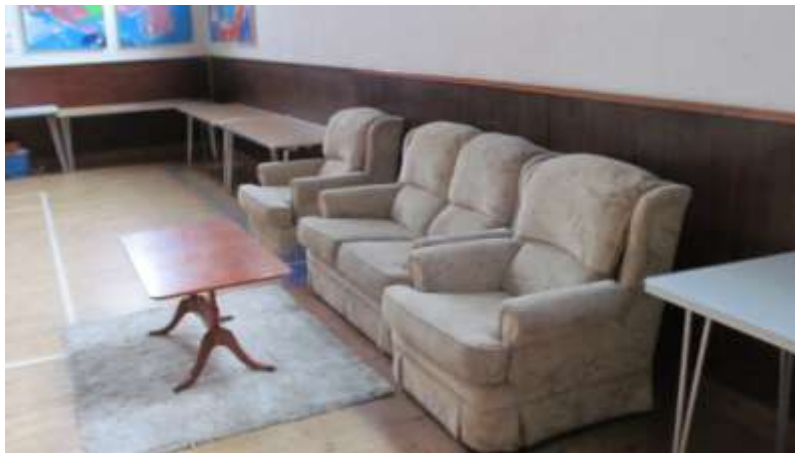
All the upholstered seating and chairs in the Victoria Street floor hall floor level do not appear to have any labels or other indications to confirm that these items of furniture conform to the current ‘Furniture and Furnishings (Fire) (Safety) Regulations 1988.

- vi) Consider replacing the upholstered furniture with approved fire safe standard furniture,
- vii) The mains electrical installation should be checked and tested by a competent electrical engineer,

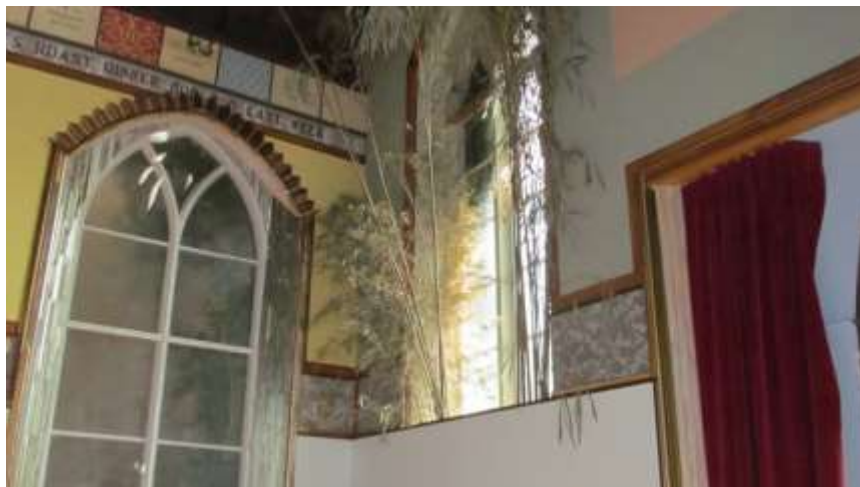
The dried foliage placed in the upper hall front windows are considered to be very combustibile, unless they are there for a particular purpose, it is recommended that they are removed from the building.

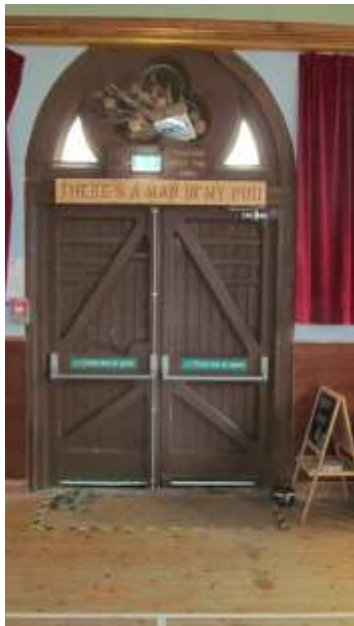
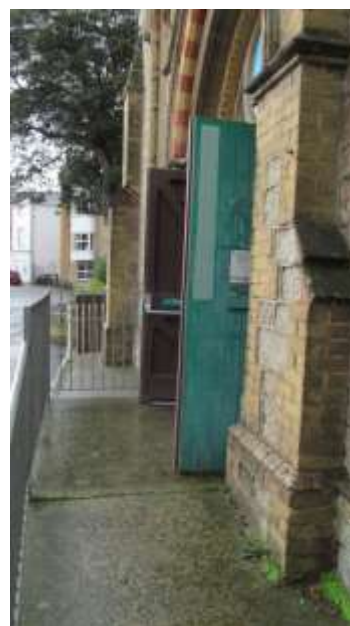
The Council should recognise that although the halls front double outward opening exit doors being 1.8m wide when both fully open, there is only an 88cm clear width between the edge of the two doors and the side railings.

Thereby, the available clear exit width around one exit door for persons to access onto the ramp down to the pavement level is considerably reduced.

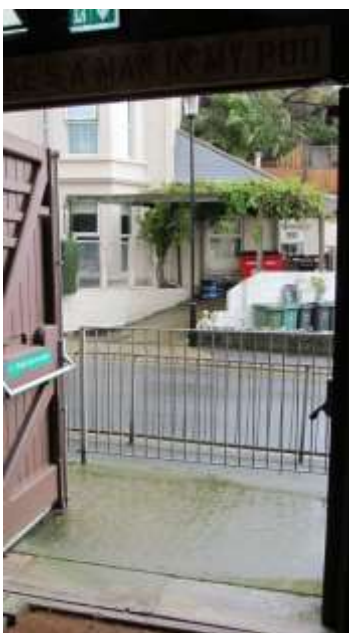
Victoria Street forms part of the towns 'one way' traffic system where it accommodates a considerable volume of traffic of all sizes, it is also recognised that the speed of the traffic can be up to and over the permitted speed limit, the Surveyor also recognises that there will be occasional part pavement parking of vehicles.
